Access Compliance Report

Public Rights-of-Way

(Curb Ramps)

Intersection ID: 16535	Main Street: ELDER_AV	Cross Street: ROSS_MOORE_AV	Location: E
ADA ID: 1A0375EBA9C9	Ramp Type: BlendTrans1	Initial Pass/Fail: Fail	Overall Compliance: No
		Severity Score: 35

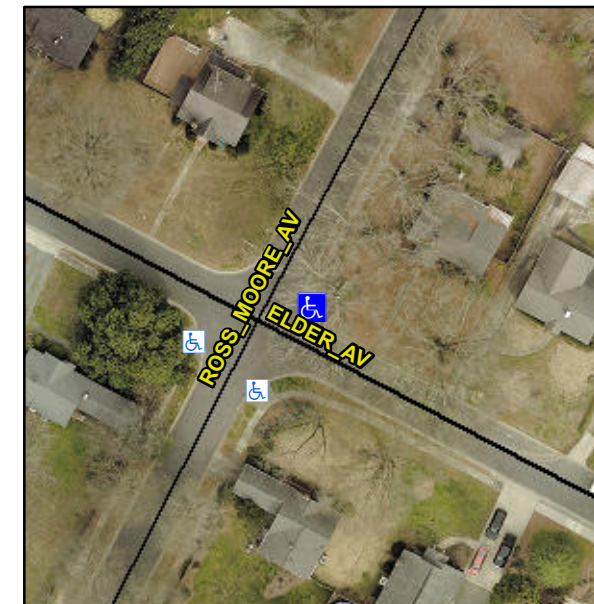
NO RT SW

Not Found, R304.5.1

Compliance	Description	Data	Compliance	Description	Data
N/A	Ramp Length (in)	84.0	Yes	BlendTrans Slope (%)	3.1
No	Ramp Width (in)	29.0	Yes	BlendTrans XSlope (%)	1.7
N/A	Flare Type LT	N/A	N/A	Flare Type RT	N/A
N/A	Flare Slope LT (%)	N/A	N/A	Flare Slope RT (%)	N/A
N/A	Flare Traversable LT?	N/A	N/A	Flare Traversable RT?	N/A
N/A	Landing Length (in)	N/A	N/A	DWS Provided?	N/A
N/A	Landing Width (in)	N/A	N/A	DWS Contrast?	N/A
N/A	Landing Slope (%)	N/A	N/A	DWS Length (in)	N/A
N/A	Landing X Slope (%)	N/A	N/A	DWS Full Width?	N/A
N/A	Landing Curb? (Y/N)	N/A	N/A	DWS Offset (in)	N/A
N/A	Shared Landing?	N/A			
N/A	Gutter Ponding?	N/A	N/A	Gutter Slope (%)	N/A
N/A	Gutter Lip Ht (in)	N/A	N/A	Gutter X Slope (%)	N/A
N/A	Painted X Walk1?	No	N/A	Painted X Walk2?	N/A
	X Walk 1 Direction	To SW		X Walk 2 Direction	N/A
	X Walk 1 Width (in)	N/A		X Walk 2 Width (in)	N/A
	X Walk 1 Slope (%)	0.4		X Walk 2 Slope (%)	N/A
	X Walk 1 X Slope (%)	1.8		X Walk 2 X Slope (%)	N/A

N/A	Ramp inside XWalk1?	N/A	N/A	Ramp inside XWalk2?	N/A
	Road Slope (%)	1.8		Clear Space?	N/A
	Road X Slope (%)	0.4	N/A	Clear Space to XWalk (in)	N/A
N/A	Any Obstructions?	N/A	N/A	Storm Grate/Utility Hazard?	N/A
	Obstruction Type			Storm Grate/Utility Type	
		N/A			N/A
			Yes	Surface Condition? (G/P)	Good
			No	Curb Slope (%)	9.4

Remove & Replace Curb Ramp With Two New Directional Ramps or Equivalent.
