Access Compliance Report

Public Rights-of-Way

(Curb Ramps)

Intersection ID: 13641	Main Street: BAY_ST	Cross Street: CLEMENT_AV	Location: S
ADA ID: 1A2443B4E94E	Ramp Type: PerpDiag	Initial Pass/Fail: Fail	Overall Compliance: No
		Severity Score: 12.5

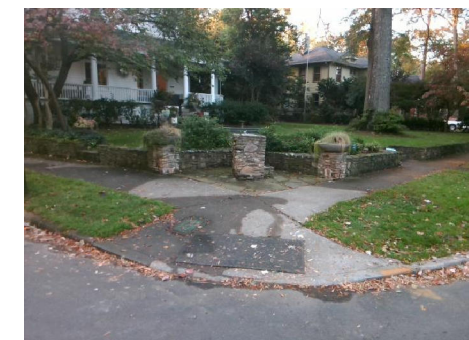
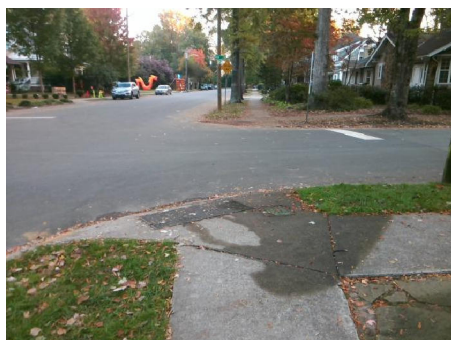
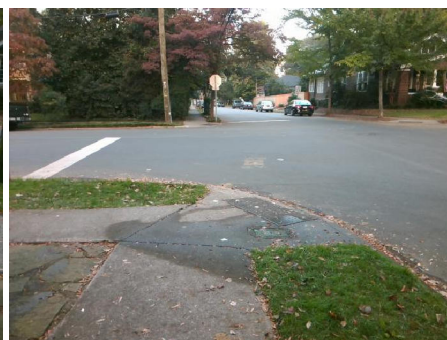
Compliance	Description	Data	Compliance	Description	Data
N/A	Ramp Length (in)	51.0	No	Ramp Slope (%)	10.6
Yes	Ramp Width (in)	63.0	Yes	Ramp XSlope (%)	0.8
N/A	Flare Type LT	N/A	N/A	Flare Type RT	N/A
N/A	Flare Slope LT (%)	N/A	N/A	Flare Slope RT (%)	N/A
N/A	Flare Traversable LT?	N/A	N/A	Flare Traversable RT?	N/A
N/A	Landing Length (in)	N/A	N/A	DWS Provided?	N/A
N/A	Landing Width (in)	N/A	N/A	DWS Contrast?	N/A
N/A	Landing Slope (%)	N/A	N/A	DWS Length (in)	N/A
N/A	Landing X Slope (%)	N/A	N/A	DWS Full Width?	N/A
N/A	Landing Curb? (Y/N)	N/A	N/A	DWS Offset (in)	N/A
N/A	Shared Landing?	N/A			
N/A	Gutter Ponding?	Yes	N/A	Gutter Slope (%)	N/A
N/A	Gutter Lip Ht (in)	N/A	N/A	Gutter X Slope (%)	N/A
N/A	Painted X Walk1?	No	N/A	Painted X Walk2?	No
	X Walk 1 Direction	To NE		X Walk 2 Direction	To NW
N/A	X Walk 1 Width (in)	N/A	N/A	X Walk 2 Width (in)	N/A
	X Walk 1 Slope (%)	4.7		X Walk 2 Slope (%)	2.9
	X Walk 1 X Slope (%)	1.9		X Walk 2 X Slope (%)	2.3

N/A	Ramp inside XWalk1?	N/A	N/A	Ramp inside XWalk2?	N/A
	Road Slope (%)	0.9	N/A	Clear Space?	N/A
	Road X Slope (%)	4.8	N/A	Clear Space to XWalk (in)	N/A
N/A	Any Obstructions?	N/A	N/A	Storm Grate/Utility Hazard?	N/A
	Obstruction Type			Storm Grate/Utility Type	
		N/A			N/A
		Yes		Surface Condition? (G/P)	Good

Possible Solutions:

Remove & Replace Curb Ramp With Two New Directional Ramps or Equivalent.

Not Found, R304.2.2
