# Access Compliance Report

## Public Rights-of-Way

| Intersection ID: 8120 | Main Street: INGLE_ST | Cross Street: TENNESSEE_AV | Location: N |
| ADA ID: 1A3570A07918 | Ramp Type: BlendTrans2 | Initial Pass/Fail: Pass | Overall Compliance: No |

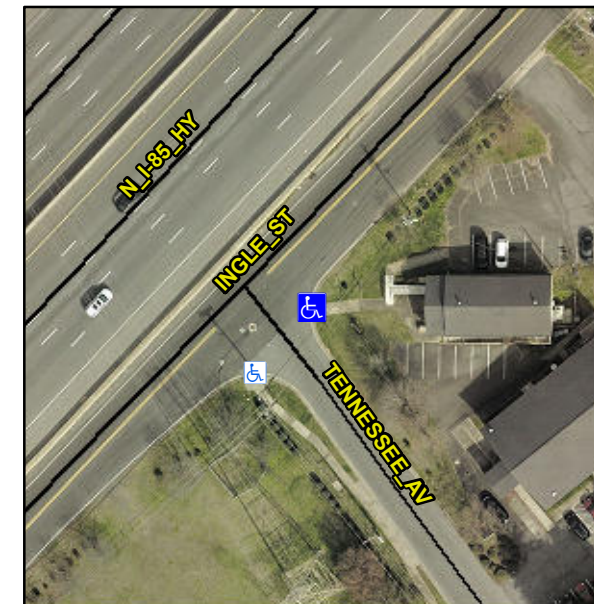
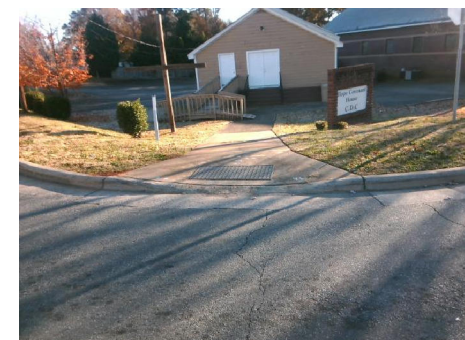
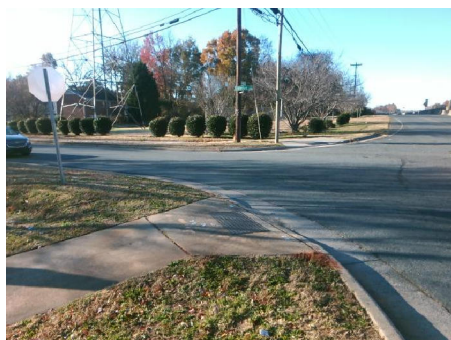
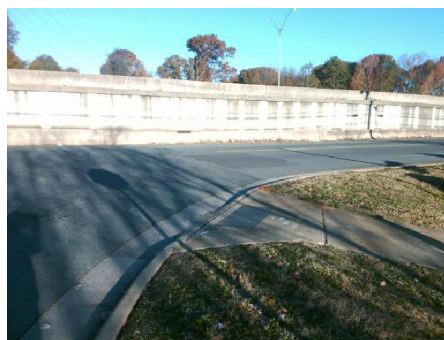
**Not Found, R304.5.3, R305.2, R302.7.2, R304.5.4**

| Compliance | Description | Data | Compliance | Description | Data |
|---|---|---|---|---|---|
| Yes | Ramp Width (in) | 52.0 | No | BlendTrans XSlope (%) | 2.2 |
| N/A | Landing Curb? (Y/N) | No | No | DWS Offset (in) | 5.0 |
| Yes | Gutter Ponding? | No | No | Gutter Slope (%) | 6.2 |
| No | Gutter Lip Ht (in) | 1.0 | No | Gutter X Slope (%) | 2.8 |
| | | | No | Curb Slope (%) | 25.3 |

**Remove & Replace Curb Ramp With Two New Directional Ramps or Equivalent. Remove & Replace Gutter.**
