Access Compliance Report

Public Rights-of-Way

(Curb Ramps)

Intersection ID: 45521	Main Street: HEDGEROW PARK RD	Cross Street: MEADOW_BOTTOM_RD	Location: W
ADA ID: 1A649C040767	Ramp Type: PerpDiag	Initial Pass/Fail: Fail	Overall Compliance: No
		Severity Score: 47.5

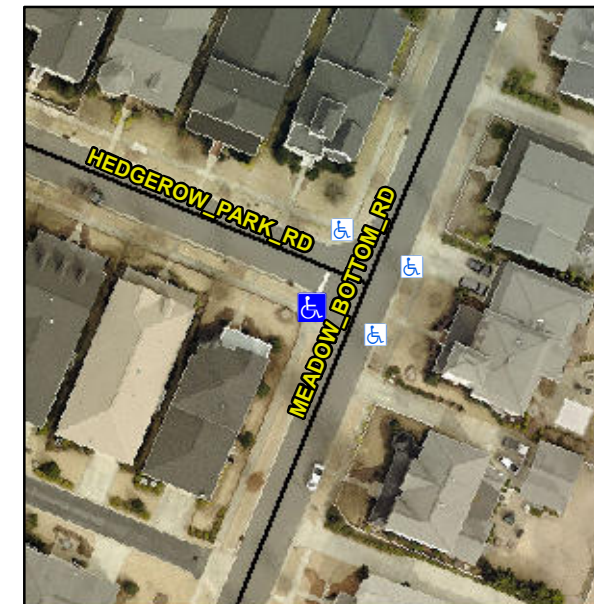
Not Found, R304.5.1, R304.2.2

Compliance	Description	Data	Compliance	Description	Data
N/A	Ramp Length (in)	73.0	No	Ramp Slope (%)	8.6
No	Ramp Width (in)	28.0	Yes	Ramp XSlope (%)	1.1
N/A	Flare Type LT	N/A	N/A	Flare Type RT	N/A
N/A	Flare Slope LT (%)	N/A	N/A	Flare Slope RT (%)	N/A
N/A	Flare Traversable LT?	N/A	N/A	Flare Traversable RT?	N/A
N/A	Landing Length (in)	N/A	N/A	DWS Provided?	N/A
N/A	Landing Width (in)	N/A	N/A	DWS Contrast?	N/A
N/A	Landing Slope (%)	N/A	N/A	DWS Length (in)	N/A
N/A	Landing X Slope (%)	N/A	N/A	DWS Full Width?	N/A
N/A	Landing Curb? (Y/N)	N/A	N/A	DWS Offset (in)	N/A
N/A	Shared Landing?	N/A			
N/A	Gutter Ponding?	N/A	N/A	Gutter Slope (%)	N/A
N/A	Gutter Lip Ht (in)	N/A	N/A	Gutter X Slope (%)	N/A
N/A	Painted X Walk1?	No	N/A	Painted X Walk2?	No
	X Walk 1 Direction	To SE		X Walk 2 Direction	To NE
N/A	X Walk 1 Width (in)	N/A	N/A	X Walk 2 Width (in)	N/A
	X Walk 1 Slope (%)	2.7		X Walk 2 Slope (%)	1.5
	X Walk 1 X Slope (%)	2.1		X Walk 2 X Slope (%)	2.1

N/A	Ramp inside XWalk1?	N/A	N/A	Ramp inside XWalk2?	N/A
	Road Slope (%)	0.6	N/A	Clear Space?	N/A
	Road X Slope (%)	3.8	N/A	Clear Space to XWalk (in)	N/A
N/A	Any Obstructions?	N/A	N/A	Storm Grate/Utility Hazard?	N/A
	Obstruction Type			Storm Grate/Utility Type	
		N/A			N/A
			Yes	Surface Condition? (G/P)	Good

Remove & Replace Curb Ramp With Two New Directional Ramps or Equivalent.

Total Cost: \$ 3200.00
