Access Compliance Report

Public Rights-of-Way

(Curb Ramps)

Intersection ID: 8727	Main Street: NEWLAND_RD	Cross Street: SAMUEL_ST	Location:	N
ADA ID: 1A6999B1D614	Ramp Type: Perp	Initial Pass/Fail: Fail	Overall Compliance: No	Severity Score: 25

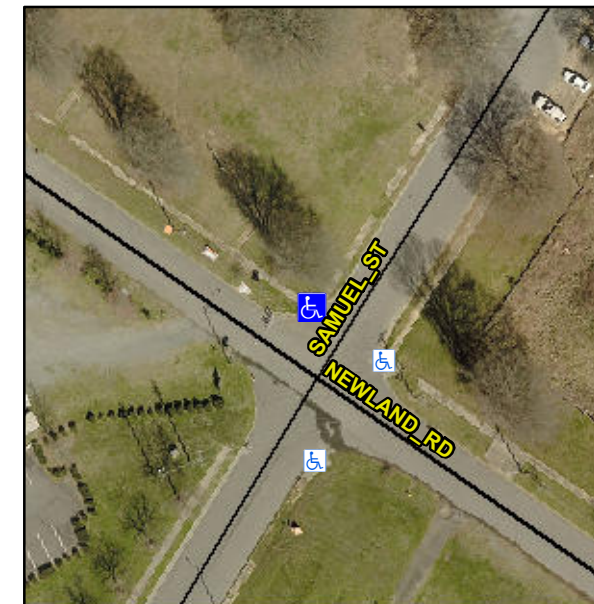
Compliance	Description	Data	Compliance	Description	Data
N/A	Ramp Length (in)	54.0	Yes	Ramp Slope (%)	7.2
Yes	Ramp Width (in)	48.0	No	Ramp XSlope (%)	7.1
N/A	Flare Type LT	N/A	N/A	Flare Type RT	N/A
N/A	Flare Slope LT (%)	N/A	N/A	Flare Slope RT (%)	N/A
N/A	Flare Traversable LT?	N/A	N/A	Flare Traversable RT?	N/A
N/A	Landing Length (in)	N/A	N/A	DWS Provided?	N/A
N/A	Landing Width (in)	N/A	N/A	DWS Contrast?	N/A
N/A	Landing Slope (%)	N/A	N/A	DWS Length (in)	N/A
N/A	Landing X Slope (%)	N/A	N/A	DWS Full Width?	N/A
N/A	Landing Curb? (Y/N)	N/A	N/A	DWS Offset (in)	N/A
N/A	Shared Landing?	N/A			
N/A	Gutter Ponding?	N/A	N/A	Gutter Slope (%)	N/A
N/A	Gutter Lip Ht (in)	N/A	N/A	Gutter X Slope (%)	N/A
N/A	Painted X Walk1?	No	N/A	Painted X Walk2?	N/A
	X Walk 1 Direction	To SE		X Walk 2 Direction	N/A
N/A	X Walk 1 Width (in)	N/A	N/A	X Walk 2 Width (in)	N/A
	X Walk 1 Slope (%)	8.3		X Walk 2 Slope (%)	N/A
	X Walk 1 X Slope (%)	2.5		X Walk 2 X Slope (%)	N/A

N/A	Ramp inside XWalk1?	N/A	N/A	Ramp inside XWalk2?	N/A
	Road Slope (%)	N/A	N/A	Clear Space?	N/A
	Road X Slope (%)	N/A	N/A	Clear Space to XWalk (in)	N/A
N/A	Any Obstructions?	N/A	N/A	Storm Grate/Utility Hazard?	N/A
	Obstruction Type			Storm Grate/Utility Type	
		N/A			N/A
			Yes	Surface Condition? (G/P)	Good

Possible Solutions:

Remove & Replace Entire Ramp.

R304.5.3

\$ 1850.00
