# Access Compliance Report

## Public Rights-of-Way

### (Curb Ramps)

Intersection ID: 3906	Main Street: BROWNE'S_FERRY_RD	Cross Street: KIRKGARD_TL	Location: E
ADA ID: 1A765D93C89A	Ramp Type: Perp	Initial Pass/Fail: Pass	Overall Compliance: No
			Severity Score: 22.75

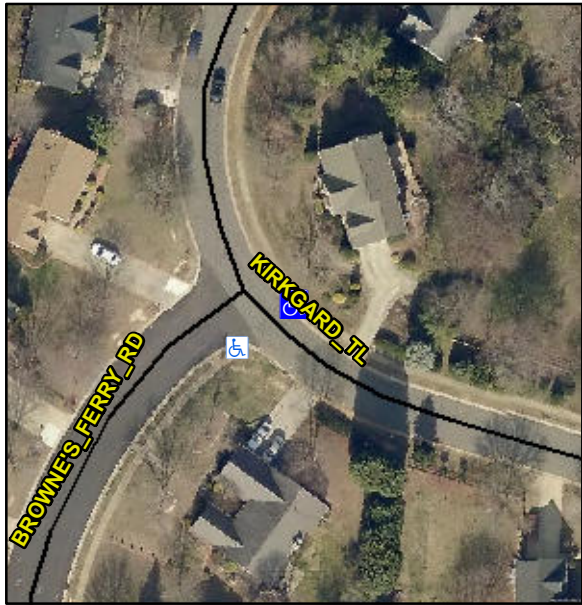
Possible Solutions:		Compliance			Description			Data	Compliance			Description			Data
	Remove & Replace Entire Ramp.		N/A	Ramp Length (in)			47.5			Yes	Ramp Slope (%)			7.8		
	Remove & Replace Gutter.		Yes	Ramp Width (in)			51.0			No	Ramp XSlope (%)			2.7		
			N/A	Flare Type LT			Sloped			N/A	Flare Type RT			N/A		
			N/A	Flare Slope LT (%)			5.6			Yes	Flare Slope RT (%)			7.2		
			N/A	Flare Traversable LT?			Yes			N/A	Flare Traversable RT?			Yes		
			No	Landing Length (in)			47.0			No	DWS Provided?			No		
			Yes	Landing Width (in)			49.0			N/A	DWS Contrast?			No		
			No	Landing Slope (%)			3.6			N/A	DWS Length (in)			N/A		
			No	Landing X Slope (%)			2.9			N/A	DWS Full Width?			No		
Surveyor Notes:		N/A	Landing Curb? (Y/N)			No			N/A	DWS Offset (in)			N/A			
PROW/ADA:		Not Found, R304.5.3, R304.2.1, R304.2.2-Perp, R304.3.2-Para, R305, R302.7.2, R304.5.4	Shared Landing?			No

Yes	Gutter Ponding?			No			No	Gutter Slope (%)			5.7		
			No	Gutter Lip Ht (in)			0.5			Yes	Gutter X Slope (%)			1.7		
			N/A	Painted X Walk1?			No			N/A	Painted X Walk2?			N/A		
				X Walk 1 Direction			To SW				X Walk 2 Direction			N/A		
			N/A	X Walk 1 Width (in)			N/A			N/A	X Walk 2 Width (in)			N/A		
				X Walk 1 Slope (%)			8.7				X Walk 2 Slope (%)			N/A		
				X Walk 1 X Slope (%)			0.3				X Walk 2 X Slope (%)			N/A		
			N/A	Ramp inside XWalk1?			N/A			N/A	Ramp inside XWalk2?			N/A		
				Road Slope (%)			N/A			N/A	Clear Space?			Yes		
				Road X Slope (%)			N/A			N/A	Clear Space to XWalk (in)			N/A		
			Yes	Any Obstructions?			No			Yes	Storm Grate/Utility Hazard?			No		
				Obstruction Type							Storm Grate/Utility Type					
										N/A				N/A		
										Yes	Surface Condition? (G/P)			Good		
Total Cost:		\$ 2600.00
