# Access Compliance Report

## Public Rights-of-Way

### (Curb Ramps)

Intersection ID: 10036003	Main Street: RIDING_TRAIL_RD	Cross Street: N/A	Location: SE
ADA ID: 1A7768EF0DAF	Ramp Type: BlendTrans2	Initial Pass/Fail: Fail	Overall Compliance: No
Severity Score: 1.25			
Codes/Mitigation Info/Possible Solution		Field Measurements/Component Compliance

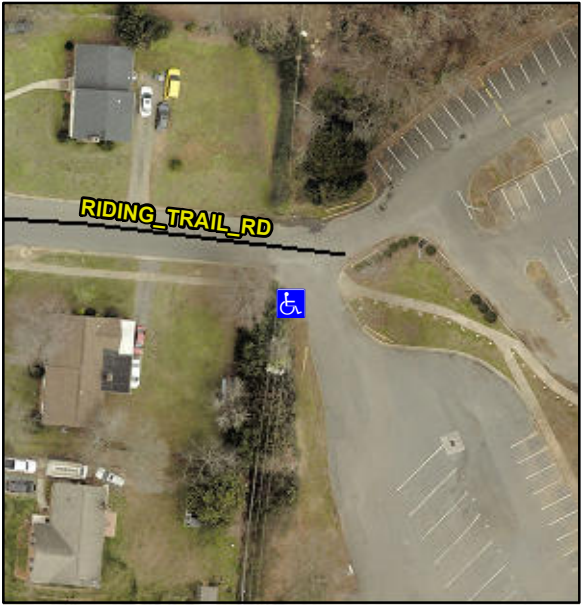
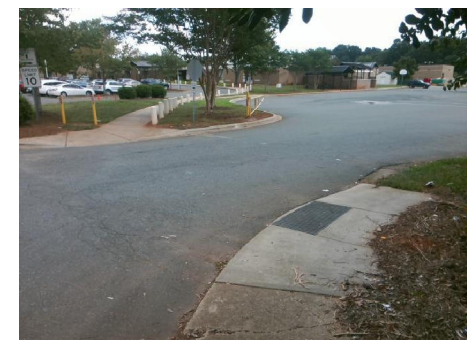
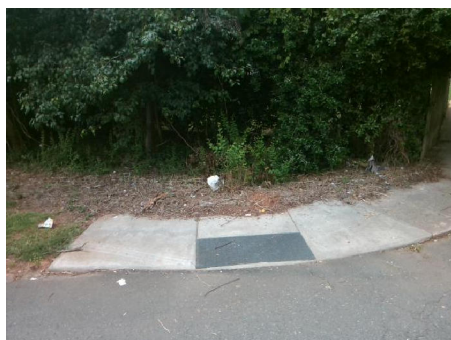
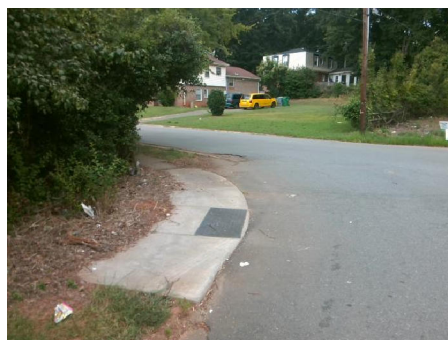
Possible Solutions:						
	Remove & Replace Curb Ramp With Two New Directional Ramps or Equivalent.	N/A	Ramp Length (in)	55.0	Yes	BlendTrans Slope (%)	3.7
		Yes	Ramp Width (in)	48.0	No	BlendTrans XSlope (%)	2.8
		N/A	Flare Type LT	N/A	N/A	Flare Type RT	N/A
		N/A	Flare Slope LT (%)	N/A	N/A	Flare Slope RT (%)	N/A
		N/A	Flare Traversable LT?	N/A	N/A	Flare Traversable RT?	N/A
		N/A	Landing Length (in)	N/A	N/A	DWS Provided?	N/A
		N/A	Landing Width (in)	N/A	N/A	DWS Contrast?	N/A
		N/A	Landing Slope (%)	N/A	N/A	DWS Length (in)	N/A
		N/A	Landing X Slope (%)	N/A	N/A	DWS Full Width?	N/A
<p>Surveyor Notes:</p> <p><b>NO CURB LNE</b></p> <p>PROW/ADA:</p> <p><b>R304.5.3</b></p>		N/A	Landing Curb? (Y/N)	N/A	N/A	DWS Offset (in)	N/A
		N/A	Shared Landing?	N/A			
		N/A	Gutter Ponding?	N/A	N/A	Gutter Slope (%)	N/A
		N/A	Gutter Lip Ht (in)	N/A	N/A	Gutter X Slope (%)	N/A
		N/A	Painted X Walk1?	No	N/A	Painted X Walk2?	N/A

X Walk 1 Direction	To NE		X Walk 2 Direction	N/A
			X Walk 1 Width (in)	N/A		X Walk 2 Width (in)	N/A
			X Walk 1 Slope (%)	0.7		X Walk 2 Slope (%)	N/A
			X Walk 1 X Slope (%)	1.7		X Walk 2 X Slope (%)	N/A
		N/A	Ramp inside XWalk1?	N/A	N/A	Ramp inside XWalk2?	N/A
<p>Street 1 Name</p> <p>Stop Condition-Street 1</p> <p>Street 2 Name</p> <p>Stop Condition-Street 2</p> <p>ENTRANCE</p> <p>StopSign</p> <p>N/A</p> <p>N/A</p>			Road Slope (%)	1.7		Clear Space?	N/A
			Road X Slope (%)	0.7	N/A	Clear Space to XWalk (in)	N/A
		N/A	Any Obstructions?	N/A	N/A	Storm Grate/Utility Hazard?	N/A
			Obstruction Type			Storm Grate/Utility Type	
					N/A		N/A
					Yes	Surface Condition? (G/P)	Good
					N/A	Curb Slope (%)	N/A
Total Cost:		\$	3200.00
