Access Compliance Report

Public Rights-of-Way

(Curb Ramps)

Intersection ID: 21073	Main Street: COLONY_RD	Cross Street: SHARON_VIEW_RD	Location: NE
ADA ID: 1A7EB9831601	Ramp Type: PerpDiag	Initial Pass/Fail: Fail	Overall Compliance: No
		Severity Score: 22.5

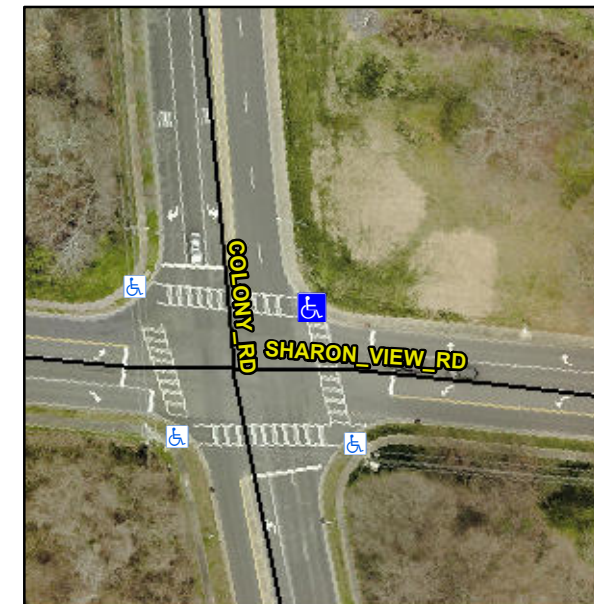
Compliance	Description	Data	Compliance	Description	Data
N/A	Ramp Length (in)	57.0	No	Ramp Slope (%)	10.5
No	Ramp Width (in)	44.0	No	Ramp XSlope (%)	2.7
N/A	Flare Type LT	N/A	N/A	Flare Type RT	N/A
N/A	Flare Slope LT (%)	N/A	N/A	Flare Slope RT (%)	N/A
N/A	Flare Traversable LT?	N/A	N/A	Flare Traversable RT?	N/A
N/A	Landing Length (in)	N/A	N/A	DWS Provided?	N/A
N/A	Landing Width (in)	N/A	N/A	DWS Contrast?	N/A
N/A	Landing Slope (%)	N/A	N/A	DWS Length (in)	N/A
N/A	Landing X Slope (%)	N/A	N/A	DWS Full Width?	N/A
N/A	Landing Curb? (Y/N)	N/A	N/A	DWS Offset (in)	N/A
N/A	Shared Landing?	N/A			
N/A	Gutter Ponding?	N/A	N/A	Gutter Slope (%)	N/A
N/A	Gutter Lip Ht (in)	N/A	N/A	Gutter X Slope (%)	N/A
N/A	Painted X Walk1?	Yes	N/A	Painted X Walk2?	Yes
	X Walk 1 Direction	To NW		X Walk 2 Direction	To S
N/A	X Walk 1 Width (in)	112.0	N/A	X Walk 2 Width (in)	104.0
	X Walk 1 Slope (%)	3.8		X Walk 2 Slope (%)	1.8
	X Walk 1 X Slope (%)	1.4		X Walk 2 X Slope (%)	1.5

N/A	Ramp inside XWalk1?	Yes	N/A	Ramp inside XWalk2?	Yes
	Road Slope (%)	0.6	N/A	Clear Space?	N/A
	Road X Slope (%)	1.3	N/A	Clear Space to XWalk (in)	N/A
N/A	Any Obstructions?	N/A	N/A	Storm Grate/Utility Hazard?	N/A
	Obstruction Type			Storm Grate/Utility Type	
		N/A			N/A
		Yes		Surface Condition? (G/P)	Good

Remove & Replace Curb Ramp With Two New Directional Ramps or Equivalent.

R304.5.1, R304.2.2, R304.5.3
