Intersection ID: 10032242	Main Street: MOSS_RD	Cross Street: N/A	Location:	SE
ADA ID: 1A85318706E7	Ramp Type: PerpDiag	Initial Pass/Fail: Fail	Overall Compliance: No	Severity Score: 12.5

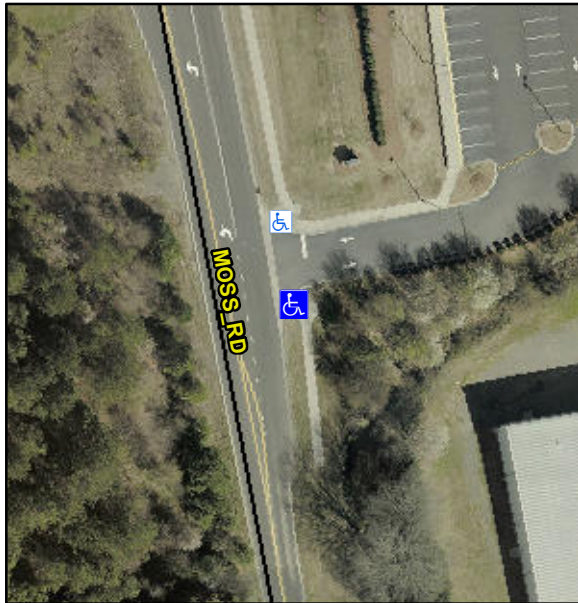
**Not Found, R304.2.2**

Compliance	Description	Data	Compliance	Description	Data
N/A	Ramp Length (in)	89.0	No	Ramp Slope (%)	8.6
Yes	Ramp Width (in)	48.0	Yes	Ramp XSlope (%)	1.2
N/A	Flare Type LT	N/A	N/A	Flare Type RT	N/A
N/A	Flare Slope LT (%)	N/A	N/A	Flare Slope RT (%)	N/A
N/A	Flare Traversable LT?	N/A	N/A	Flare Traversable RT?	N/A
N/A	Landing Length (in)	N/A	N/A	DWS Provided?	N/A
N/A	Landing Width (in)	N/A	N/A	DWS Contrast?	N/A
N/A	Landing Slope (%)	N/A	N/A	DWS Length (in)	N/A
N/A	Landing X Slope (%)	N/A	N/A	DWS Full Width?	N/A
N/A	Landing Curb? (Y/N)	N/A	N/A	DWS Offset (in)	N/A
N/A	Shared Landing?	N/A			
N/A	Gutter Ponding?	N/A	N/A	Gutter Slope (%)	N/A
N/A	Gutter Lip Ht (in)	N/A	N/A	Gutter X Slope (%)	N/A
N/A	Painted X Walk1?	No	N/A	Painted X Walk2?	No
	X Walk 1 Direction	To N		X Walk 2 Direction	To W
N/A	X Walk 1 Width (in)	N/A	N/A	X Walk 2 Width (in)	N/A
	X Walk 1 Slope (%)	1.6		X Walk 2 Slope (%)	1.8
	X Walk 1 X Slope (%)	1.3		X Walk 2 X Slope (%)	0.0

N/A	Ramp inside XWalk1?	N/A	N/A	Ramp inside XWalk2?	N/A
	Road Slope (%)	2.7	N/A	Clear Space?	N/A
	Road X Slope (%)	0.4	N/A	Clear Space to XWalk (in)	N/A
N/A	Any Obstructions?	N/A	N/A	Storm Grate/Utility Hazard?	N/A
	Obstruction Type			Storm Grate/Utility Type	
		N/A			N/A
			Yes	Surface Condition? (G/P)	Good

**Remove & Replace Curb Ramp With Two New Directional Ramps or Equivalent.**
