# Access Compliance Report

## Public Rights-of-Way

### (Curb Ramps)

Intersection ID: 8350	Main Street: LASALLE_ST	Cross Street: CUSTER_ST	Location: SW
ADA ID: 1A90DC922390	Ramp Type: Perp	Initial Pass/Fail: Fail	Overall Compliance: No
		Severity Score: 22.5

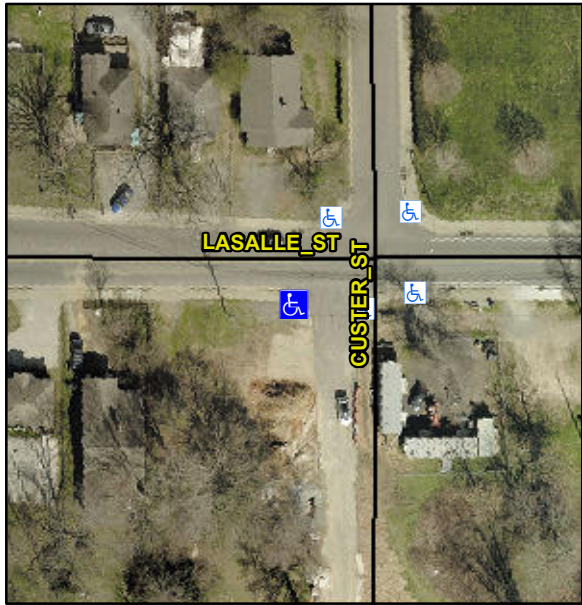
Possible Solutions:		Compliance	Description	Data	Compliance	Description	Data
	Remove & Replace Entire Ramp.		N/A	Ramp Length (in)	59.5	No	Ramp Slope (%)	10.0
			No	Ramp Width (in)	36.0	No	Ramp XSlope (%)	5.0
			N/A	Flare Type LT	N/A	N/A	Flare Type RT	N/A
			N/A	Flare Slope LT (%)	N/A	N/A	Flare Slope RT (%)	N/A
			N/A	Flare Traversable LT?	N/A	N/A	Flare Traversable RT?	N/A
			N/A	Landing Length (in)	N/A	N/A	DWS Provided?	N/A
			N/A	Landing Width (in)	N/A	N/A	DWS Contrast?	N/A
			N/A	Landing Slope (%)	N/A	N/A	DWS Length (in)	N/A
			N/A	Landing X Slope (%)	N/A	N/A	DWS Full Width?	N/A
<p>Surveyor Notes:</p> <p>N/A</p> <p>PROW/ADA:</p> <p>Not Found, R304.5.1, R304.2.2, R304.5.3</p>			N/A	Landing Curb? (Y/N)	N/A	N/A	DWS Offset (in)	N/A
			N/A	Shared Landing?	N/A			
			N/A	Gutter Ponding?	N/A	N/A	Gutter Slope (%)	N/A
			N/A	Gutter Lip Ht (in)	0.5	N/A	Gutter X Slope (%)	N/A

N/A	Painted X Walk1?	No	N/A	Painted X Walk2?	N/A
				X Walk 1 Direction	To E		X Walk 2 Direction	N/A
			N/A	X Walk 1 Width (in)	N/A	N/A	X Walk 2 Width (in)	N/A
				X Walk 1 Slope (%)	1.0		X Walk 2 Slope (%)	N/A
				X Walk 1 X Slope (%)	3.6		X Walk 2 X Slope (%)	N/A
			N/A	Ramp inside XWalk1?	N/A	N/A	Ramp inside XWalk2?	N/A
			Road Slope (%)	N/A	N/A	Clear Space?	N/A	
			Road X Slope (%)	N/A	N/A	Clear Space to XWalk (in)	N/A	
		N/A	Any Obstructions?	N/A	N/A	Storm Grate/Utility Hazard?	N/A	
			Obstruction Type			Storm Grate/Utility Type		
					N/A			N/A
						Yes	Surface Condition? (G/P)	Good
