Access Compliance Report

Public Rights-of-Way

(Curb Ramps)

Intersection ID: 26038	Main Street: ELM_LN	Cross Street: PINEVILLE-MATTHEWS_RD	Location: SW
ADA ID: 1AA173BE49F7	Ramp Type: PerpDiag	Initial Pass/Fail: Fail	Overall Compliance: No
Codes/Mitigation Info/Possible Solution		Field Measurements/Component Compliance	
		Severity Score: 42.5

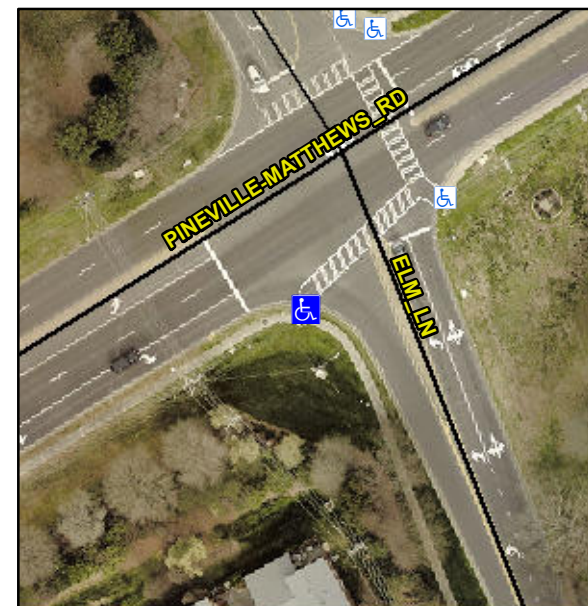
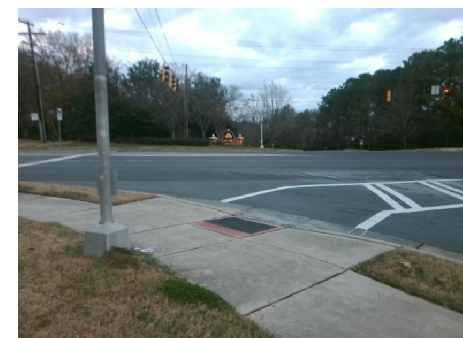
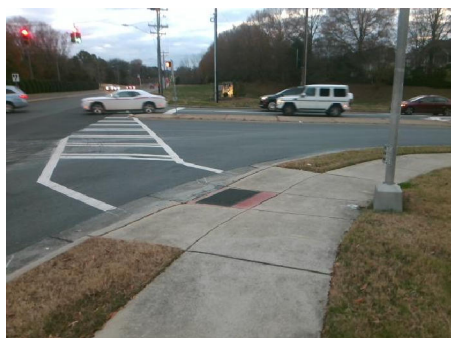
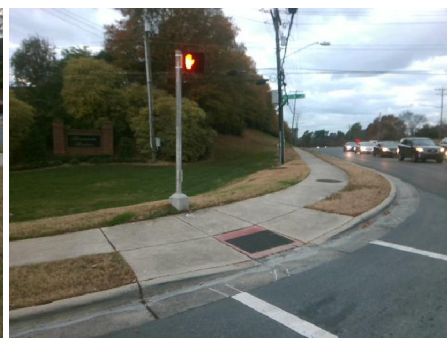
R304.5.1, R304.2.2, R304.5.3

Compliance	Description	Data	Compliance	Description	Data
N/A	Ramp Length (in)	107.0	No	Ramp Slope (%)	8.4
No	Ramp Width (in)	35.0	No	Ramp XSlope (%)	5.3
N/A	Flare Type LT	N/A	N/A	Flare Type RT	N/A
N/A	Flare Slope LT (%)	N/A	N/A	Flare Slope RT (%)	N/A
N/A	Flare Traversable LT?	N/A	N/A	Flare Traversable RT?	N/A
N/A	Landing Length (in)	N/A	N/A	DWS Provided?	N/A
N/A	Landing Width (in)	N/A	N/A	DWS Contrast?	N/A
N/A	Landing Slope (%)	N/A	N/A	DWS Length (in)	N/A
N/A	Landing X Slope (%)	N/A	N/A	DWS Full Width?	N/A
N/A	Landing Curb? (Y/N)	N/A	N/A	DWS Offset (in)	N/A
N/A	Shared Landing?	N/A			
N/A	Gutter Ponding?	N/A	N/A	Gutter Slope (%)	N/A
N/A	Gutter Lip Ht (in)	N/A	N/A	Gutter X Slope (%)	N/A
N/A	Painted X Walk1?	Yes	N/A	Painted X Walk2?	No
	X Walk 1 Direction	To NE		X Walk 2 Direction	To NW
N/A	X Walk 1 Width (in)	108.0	N/A	X Walk 2 Width (in)	N/A
	X Walk 1 Slope (%)	5.0		X Walk 2 Slope (%)	5.0
	X Walk 1 X Slope (%)	4.2		X Walk 2 X Slope (%)	0.3

N/A	Ramp inside XWalk1?	Yes	N/A	Ramp inside XWalk2?	N/A
	Road Slope (%)	4.4	N/A	Clear Space?	N/A
	Road X Slope (%)	6.5	N/A	Clear Space to XWalk (in)	N/A
N/A	Any Obstructions?	N/A	N/A	Storm Grate/Utility Hazard?	N/A
	Obstruction Type			Storm Grate/Utility Type	
		N/A			N/A
		Yes		Surface Condition? (G/P)	Good

Possible Solutions:

Remove & Replace Curb Ramp With Two New Directional Ramps or Equivalent.
