Access Compliance Report Public Rights-of-Way (Curb Ramps)

Intersection ID: 45155 Main Street: SHAD CT Cross Street: MAGNASCO LN Location: N **Overall Compliance: No** 10 ADA ID: 1AAD386F1FFC Ramp Type: Perp Initial Pass/Fail: Fail **Severity Score:**

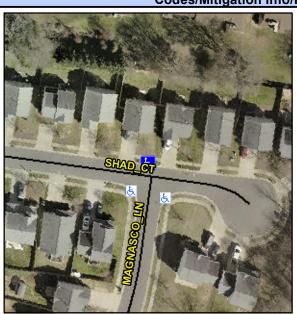
ossible Solution		Field Me
Possible Solutions:	Comp	liance Description
Remove & Replace Entire Ramp.	N/A	Ramp Length (in)
·	No	Ramp Width (in)
	N/A	Flare Type LT
	N/A	Flare Slope LT (%)
	N/A	Flare Traversable LT
	N/A	Landing Length (in)
Surveyor Notes:	N/A	Landing Width (in)
N/A	N/A	Landing Slope (%)
	N/A	Landing X Slope (%
	N/A	Landing Curb? (Y/N
	N/A	Shared Landing?
PROW/ADA:	N/A	Gutter Ponding?
Not Found, R304.5.1	N/A	Gutter Lip Ht (in)
	N/A	Painted X Walk1?
		X Walk 1 Direction
	N/A	X Walk 1 Width (in)
		X Walk 1 Slope (%)
		X Walk 1 X Slope (%
	N/A	Ramp inside XWalk
		Road Slope (%)
