# Access Compliance Report

## Public Rights-of-Way

### (Curb Ramps)

Intersection ID: N/A	Main Street: E_TRADE_ST	Cross Street: S_COLLEGE_ST	Location: N
ADA ID: 1AB5F578005C	Ramp Type: Perp	Initial Pass/Fail: Fail	Overall Compliance: No
		Severity Score: 12.5

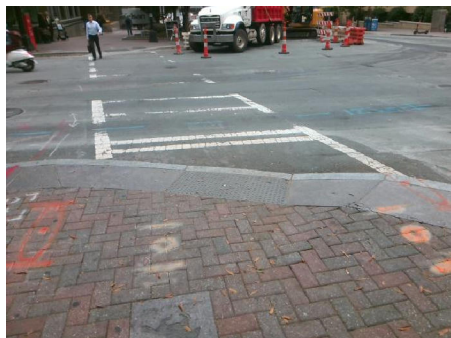
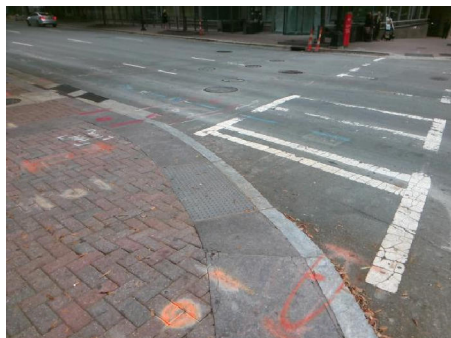
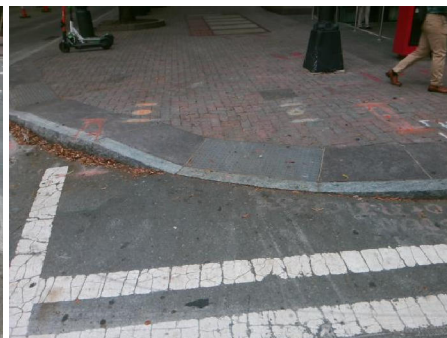
Compliance	Description	Data	Compliance	Description	Data
N/A	Ramp Length (in)	60.0	No	Ramp Slope (%)	8.9
Yes	Ramp Width (in)	48.0	Yes	Ramp XSlope (%)	0.9
N/A	Flare Type LT	N/A	N/A	Flare Type RT	N/A
N/A	Flare Slope LT (%)	N/A	N/A	Flare Slope RT (%)	N/A
N/A	Flare Traversable LT?	N/A	N/A	Flare Traversable RT?	N/A
N/A	Landing Length (in)	N/A	N/A	DWS Provided?	N/A
N/A	Landing Width (in)	N/A	N/A	DWS Contrast?	N/A
N/A	Landing Slope (%)	N/A	N/A	DWS Length (in)	N/A
N/A	Landing X Slope (%)	N/A	N/A	DWS Full Width?	N/A
N/A	Landing Curb? (Y/N)	N/A	N/A	DWS Offset (in)	N/A
N/A	Shared Landing?	N/A			
N/A	Gutter Ponding?	N/A	N/A	Gutter Slope (%)	N/A
N/A	Gutter Lip Ht (in)	N/A	N/A	Gutter X Slope (%)	N/A
N/A	Painted X Walk1?	Yes	N/A	Painted X Walk2?	N/A
	X Walk 1 Direction	To SE		X Walk 2 Direction	N/A
N/A	X Walk 1 Width (in)	114.0	N/A	X Walk 2 Width (in)	N/A
	X Walk 1 Slope (%)	4.4		X Walk 2 Slope (%)	N/A
	X Walk 1 X Slope (%)	0.3		X Walk 2 X Slope (%)	N/A

N/A	Ramp inside XWalk1?	Yes	N/A	Ramp inside XWalk2?	N/A
	Road Slope (%)	N/A	N/A	Clear Space?	N/A
	Road X Slope (%)	N/A	N/A	Clear Space to XWalk (in)	N/A
N/A	Any Obstructions?	N/A	N/A	Storm Grate/Utility Hazard?	N/A
	Obstruction Type			Storm Grate/Utility Type	
		N/A			N/A
		Yes		Surface Condition? (G/P)	Good

**Remove & Replace Entire Ramp.**

**R304.2.2**
