Access Compliance Report

Public Rights-of-Way

(Curb Ramps)

Intersection ID: 18920	Main Street: TYVOLA_RD	Cross Street: WESTPARK_DR	Location: SE
ADA ID: 1AB8A2DFB8C8	Ramp Type: PerpDiag	Initial Pass/Fail: Fail	Overall Compliance: No
		Severity Score: 35

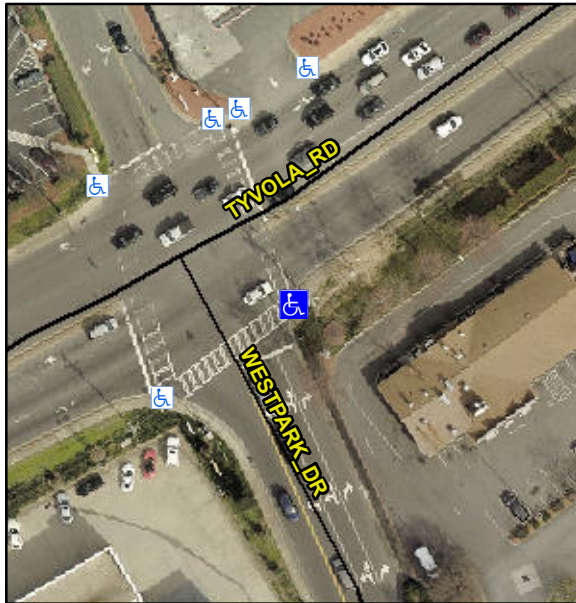
Not Found, R304.5.1, R304.2.2, R304.5.3

Compliance	Description	Data	Compliance	Description	Data
N/A	Ramp Length (in)	60.0	No	Ramp Slope (%)	12.1
No	Ramp Width (in)	38.5	No	Ramp XSlope (%)	2.7
N/A	Flare Type LT	N/A	N/A	Flare Type RT	N/A
N/A	Flare Slope LT (%)	N/A	N/A	Flare Slope RT (%)	N/A
N/A	Flare Traversable LT?	N/A	N/A	Flare Traversable RT?	N/A
N/A	Landing Length (in)	N/A	N/A	DWS Provided?	N/A
N/A	Landing Width (in)	N/A	N/A	DWS Contrast?	N/A
N/A	Landing Slope (%)	N/A	N/A	DWS Length (in)	N/A
N/A	Landing X Slope (%)	N/A	N/A	DWS Full Width?	N/A
N/A	Landing Curb? (Y/N)	N/A	N/A	DWS Offset (in)	N/A
N/A	Shared Landing?	N/A			
N/A	Gutter Ponding?	N/A	N/A	Gutter Slope (%)	N/A
N/A	Gutter Lip Ht (in)	N/A	N/A	Gutter X Slope (%)	N/A
N/A	Painted X Walk1?	Yes	N/A	Painted X Walk2?	Yes
	X Walk 1 Direction	To NW		X Walk 2 Direction	To SW
N/A	X Walk 1 Width (in)	67.0	N/A	X Walk 2 Width (in)	106.0
	X Walk 1 Slope (%)	1.9		X Walk 2 Slope (%)	1.7
	X Walk 1 X Slope (%)	1.9		X Walk 2 X Slope (%)	1.8

N/A	Ramp inside XWalk1?	Yes	N/A	Ramp inside XWalk2?	Yes
	Road Slope (%)	2.0	N/A	Clear Space?	N/A
	Road X Slope (%)	1.0	N/A	Clear Space to XWalk (in)	N/A
N/A	Any Obstructions?	N/A	N/A	Storm Grate/Utility Hazard?	N/A
	Obstruction Type			Storm Grate/Utility Type	
		N/A			N/A
		Yes		Surface Condition? (G/P)	Good

Remove & Replace Curb Ramp With Two New Directional Ramps or Equivalent.
