# Access Compliance Report

## Public Rights-of-Way

### (Curb Ramps)

Intersection ID: 43210	Main Street: ENDERLY_RD	Cross Street: MATHIS_DR	Location: S
ADA ID: 1AB9FA9B7EF3	Ramp Type: PerpDiag	Initial Pass/Fail: Fail	Overall Compliance: No
		Severity Score: 10

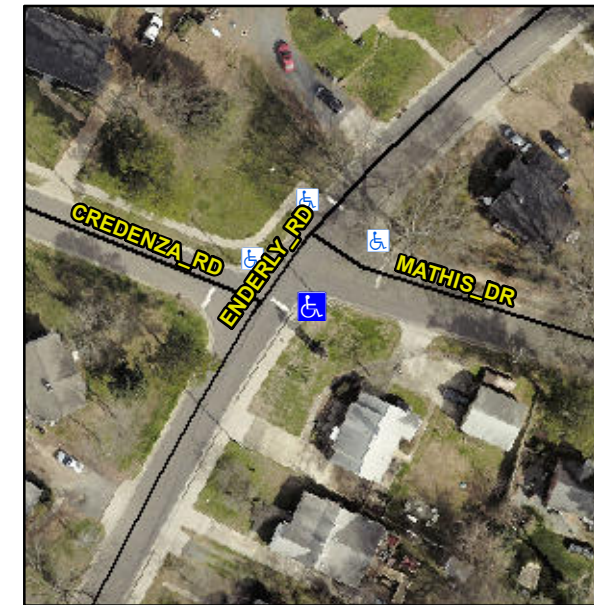
Compliance	Description	Data	Compliance	Description	Data
N/A	Ramp Length (in)	74.0	Yes	Ramp Slope (%)	5.5
No	Ramp Width (in)	43.0	No	Ramp XSlope (%)	4.2
N/A	Flare Type LT	N/A	N/A	Flare Type RT	N/A
N/A	Flare Slope LT (%)	N/A	N/A	Flare Slope RT (%)	N/A
N/A	Flare Traversable LT?	N/A	N/A	Flare Traversable RT?	N/A
N/A	Landing Length (in)	N/A	N/A	DWS Provided?	N/A
N/A	Landing Width (in)	N/A	N/A	DWS Contrast?	N/A
N/A	Landing Slope (%)	N/A	N/A	DWS Length (in)	N/A
N/A	Landing X Slope (%)	N/A	N/A	DWS Full Width?	N/A
N/A	Landing Curb? (Y/N)	N/A	N/A	DWS Offset (in)	N/A
N/A	Shared Landing?	N/A			
N/A	Gutter Ponding?	N/A	N/A	Gutter Slope (%)	N/A
N/A	Gutter Lip Ht (in)	N/A	N/A	Gutter X Slope (%)	N/A
N/A	Painted X Walk1?	No	N/A	Painted X Walk2?	No
	X Walk 1 Direction	To NE		X Walk 2 Direction	To NW
N/A	X Walk 1 Width (in)	N/A	N/A	X Walk 2 Width (in)	N/A
	X Walk 1 Slope (%)	5.3		X Walk 2 Slope (%)	0.3
	X Walk 1 X Slope (%)	3.2		X Walk 2 X Slope (%)	5.6

N/A	Ramp inside XWalk1?	N/A	N/A	Ramp inside XWalk2?	N/A
	Road Slope (%)	2.4	N/A	Clear Space?	N/A
	Road X Slope (%)	4.0	N/A	Clear Space to XWalk (in)	N/A
N/A	Any Obstructions?	N/A	N/A	Storm Grate/Utility Hazard?	N/A
	Obstruction Type			Storm Grate/Utility Type	
		N/A			N/A
			Yes	Surface Condition? (G/P)	Good

**Remove & Replace Curb Ramp With Two New Directional Ramps or Equivalent.**

**R304.5.1, R304.5.3**
