# Access Compliance Report

## Public Rights-of-Way

### (Curb Ramps)

| Intersection ID: 10024831 | Main Street: DENMARK_RD | Cross Street: N/A | Location: W |

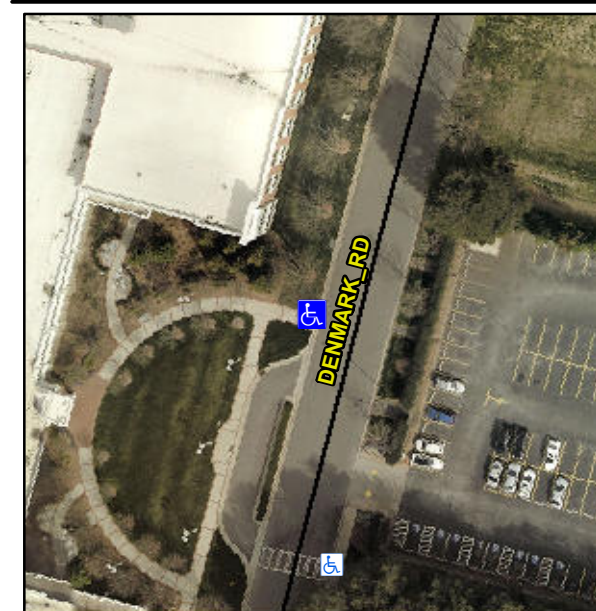
| ADA ID: 1AC70135F94C | Ramp Type: Perp | Initial Pass/Fail: Pass | Overall Compliance: No |
| | | Severity Score: 5 | |

| Compliance | Description | Data | Compliance | Description | Data |
|---|---|---|---|---|---|
| No | Landing Slope (%) | 4.1 | Yes | DWS Length (in) | 24.0 |
| Yes | Gutter Ponding? | No | No | Gutter Slope (%) | 5.3 |

**Remove & Replace Entire Ramp.  
Remove & Replace Gutter.**

**Not Found, R304.2.2-Perp, R304.3.2-Para, R304.5.4**

Total Cost: \$ 2600.00
