Access Compliance Report

Public Rights-of-Way

(Curb Ramps)

Intersection ID: 15566	Main Street: HOPEDALE_AV	Cross Street: S_KINGS_DR	Location: SE
ADA ID: 1ACE591AEC8	Ramp Type: PerpDiag	Initial Pass/Fail: Fail	Overall Compliance: No
		Severity Score: 12.5

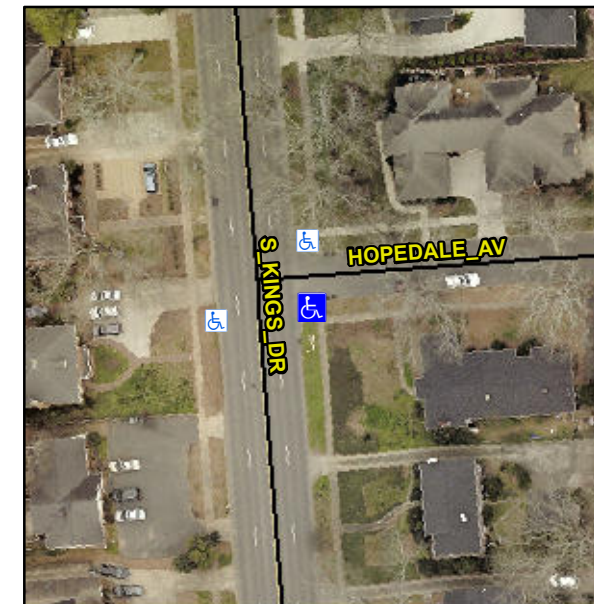
Compliance	Description	Data	Compliance	Description	Data
N/A	Ramp Length (in)	90.0	Yes	Ramp Slope (%)	7.2
Yes	Ramp Width (in)	48.0	No	Ramp XSlope (%)	5.5
N/A	Flare Type LT	N/A	N/A	Flare Type RT	N/A
N/A	Flare Slope LT (%)	N/A	N/A	Flare Slope RT (%)	N/A
N/A	Flare Traversable LT?	N/A	N/A	Flare Traversable RT?	N/A
N/A	Landing Length (in)	N/A	N/A	DWS Provided?	N/A
N/A	Landing Width (in)	N/A	N/A	DWS Contrast?	N/A
N/A	Landing Slope (%)	N/A	N/A	DWS Length (in)	N/A
N/A	Landing X Slope (%)	N/A	N/A	DWS Full Width?	N/A
N/A	Landing Curb? (Y/N)	N/A	N/A	DWS Offset (in)	N/A
N/A	Shared Landing?	N/A			
N/A	Gutter Ponding?	N/A	N/A	Gutter Slope (%)	N/A
N/A	Gutter Lip Ht (in)	N/A	N/A	Gutter X Slope (%)	N/A
N/A	Painted X Walk1?	No	N/A	Painted X Walk2?	No
	X Walk 1 Direction	To N		X Walk 2 Direction	To W
N/A	X Walk 1 Width (in)	N/A	N/A	X Walk 2 Width (in)	N/A
	X Walk 1 Slope (%)	3.0		X Walk 2 Slope (%)	1.9
	X Walk 1 X Slope (%)	3.3		X Walk 2 X Slope (%)	2.6

N/A	Ramp inside XWalk1?	N/A	N/A	Ramp inside XWalk2?	N/A
	Road Slope (%)	2.8	N/A	Clear Space?	N/A
	Road X Slope (%)	4.5	N/A	Clear Space to XWalk (in)	N/A
N/A	Any Obstructions?	N/A	N/A	Storm Grate/Utility Hazard?	N/A
	Obstruction Type			Storm Grate/Utility Type	
		N/A			N/A
		Yes		Surface Condition? (G/P)	Good

Remove & Replace Curb Ramp With Two New Directional Ramps or Equivalent.

R304.5.3

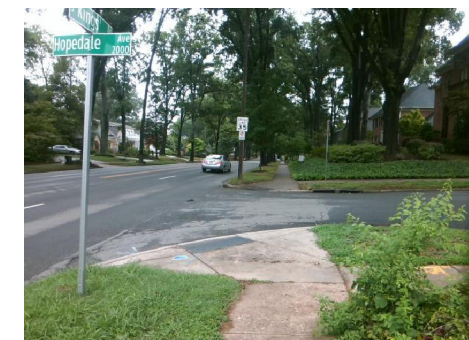
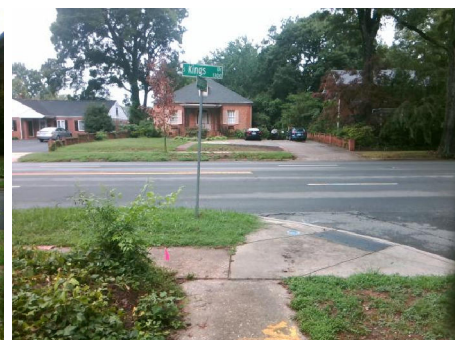
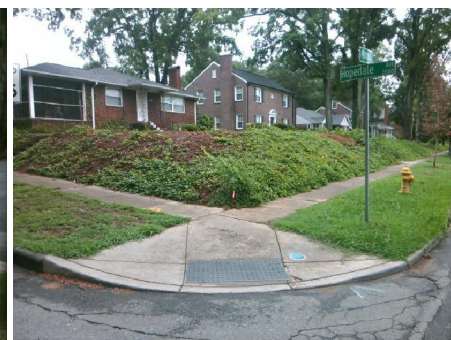
Street 1 Name **HOPEDALE AV**
 Stop Condition-Street 2 **StopSign**
 Street 2 Name **S KINGS DR**
 Stop Condition-Street 1 **None**
