# Access Compliance Report

## Public Rights-of-Way

### (Curb Ramps)

Intersection ID: 7656	Main Street: GARFIELD_ST	Cross Street: MORGAN_ST	Location: E
ADA ID: 1AD27A72EC07	Ramp Type: BlendTrans2	Initial Pass/Fail: Fail	Overall Compliance: No
		Severity Score: 10

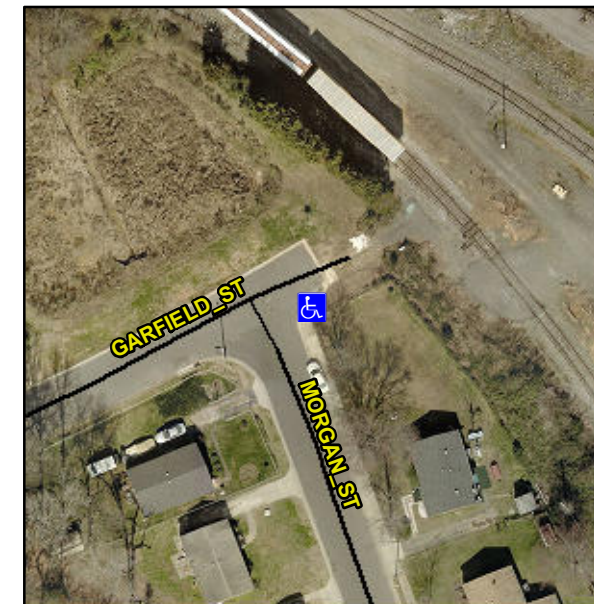
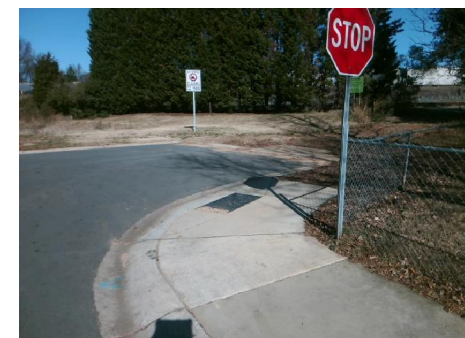
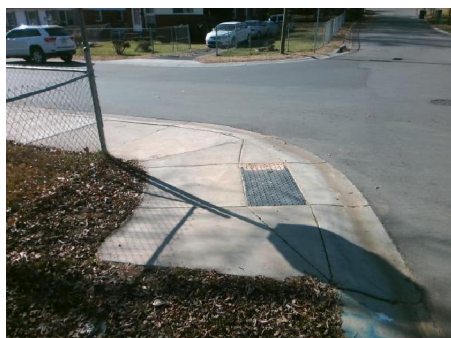
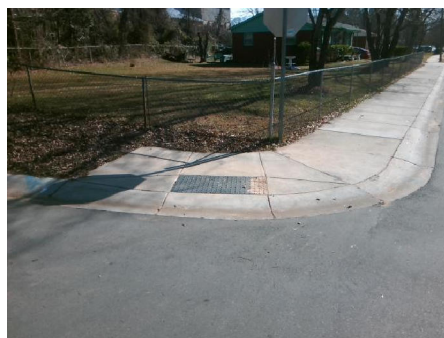
**Not Found, R304.5.1, R304.5.3**

Compliance	Description	Data	Compliance	Description	Data
N/A	Ramp Length (in)	69.0	Yes	BlendTrans Slope (%)	1.2
No	Ramp Width (in)	47.5	No	BlendTrans XSlope (%)	3.4
N/A	Flare Type LT	N/A	N/A	Flare Type RT	N/A
N/A	Flare Slope LT (%)	N/A	N/A	Flare Slope RT (%)	N/A
N/A	Flare Traversable LT?	N/A	N/A	Flare Traversable RT?	N/A
N/A	Landing Length (in)	N/A	N/A	DWS Provided?	N/A
N/A	Landing Width (in)	N/A	N/A	DWS Contrast?	N/A
N/A	Landing Slope (%)	N/A	N/A	DWS Length (in)	N/A
N/A	Landing X Slope (%)	N/A	N/A	DWS Full Width?	N/A
N/A	Landing Curb? (Y/N)	N/A	N/A	DWS Offset (in)	N/A
N/A	Shared Landing?	N/A			
N/A	Gutter Ponding?	N/A	N/A	Gutter Slope (%)	N/A
N/A	Gutter Lip Ht (in)	N/A	N/A	Gutter X Slope (%)	N/A
N/A	Painted X Walk1?	No	N/A	Painted X Walk2?	N/A
	X Walk 1 Direction	To W		X Walk 2 Direction	N/A
	X Walk 1 Width (in)	N/A		X Walk 2 Width (in)	N/A
	X Walk 1 Slope (%)	5.9		X Walk 2 Slope (%)	N/A
	X Walk 1 X Slope (%)	2.7		X Walk 2 X Slope (%)	N/A

N/A	Ramp inside XWalk1?	N/A	N/A	Ramp inside XWalk2?	N/A
	Road Slope (%)	2.7		Clear Space?	N/A
	Road X Slope (%)	5.9	N/A	Clear Space to XWalk (in)	N/A
N/A	Any Obstructions?	N/A	N/A	Storm Grate/Utility Hazard?	N/A
	Obstruction Type			Storm Grate/Utility Type	
		N/A			N/A
			Yes	Surface Condition? (G/P)	Good
			No	Curb Slope (%)	13.8

**Remove & Replace Curb Ramp With Two New Directional Ramps or Equivalent.**
