Access Compliance Report

Public Rights-of-Way

(Curb Ramps)

Intersection ID: 24455	Main Street: S_TRYON_ST	Cross Street: STEELE_CREEK_RD	Location: NE
ADA ID: 1ADB843D82E2	Ramp Type: Perp	Initial Pass/Fail: Fail	Overall Compliance: No
Severity Score: 10			
Codes/Mitigation Info/Possible Solution		Field Measurements/Component Compliance

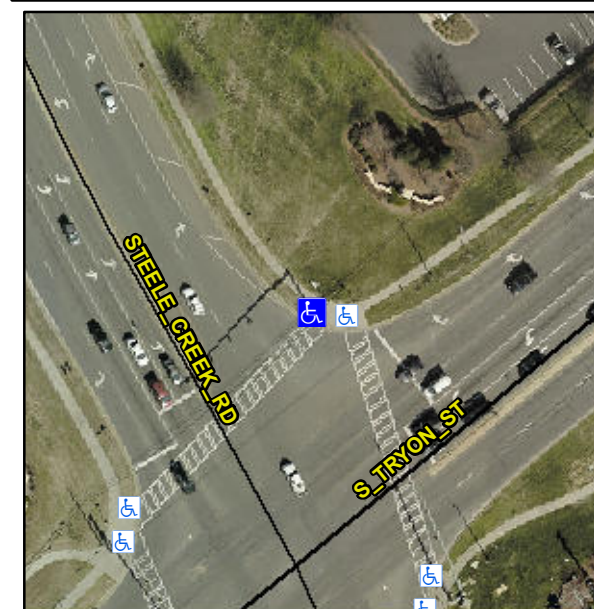
Not Found, R304.5.1, R304.5.3

Compliance	Description	Data	Compliance	Description	Data
N/A	Ramp Length (in)	84.0	Yes	Ramp Slope (%)	6.6
No	Ramp Width (in)	47.0	No	Ramp XSlope (%)	2.6
N/A	Flare Type LT	N/A	N/A	Flare Type RT	N/A
N/A	Flare Slope LT (%)	N/A	N/A	Flare Slope RT (%)	N/A
N/A	Flare Traversable LT?	N/A	N/A	Flare Traversable RT?	N/A
N/A	Landing Length (in)	N/A	N/A	DWS Provided?	N/A
N/A	Landing Width (in)	N/A	N/A	DWS Contrast?	N/A
N/A	Landing Slope (%)	N/A	N/A	DWS Length (in)	N/A
N/A	Landing X Slope (%)	N/A	N/A	DWS Full Width?	N/A
N/A	Landing Curb? (Y/N)	N/A	N/A	DWS Offset (in)	N/A
N/A	Shared Landing?	N/A			
N/A	Gutter Ponding?	N/A	N/A	Gutter Slope (%)	N/A
N/A	Gutter Lip Ht (in)	N/A	N/A	Gutter X Slope (%)	N/A
N/A	Painted X Walk1?	Yes	N/A	Painted X Walk2?	N/A
	X Walk 1 Direction	To SW		X Walk 2 Direction	N/A
N/A	X Walk 1 Width (in)	120.0	N/A	X Walk 2 Width (in)	N/A
	X Walk 1 Slope (%)	1.7		X Walk 2 Slope (%)	N/A
	X Walk 1 X Slope (%)	2.2		X Walk 2 X Slope (%)	N/A

N/A	Ramp inside XWalk1?	Yes	N/A	Ramp inside XWalk2?	N/A
	Road Slope (%)	N/A	N/A	Clear Space?	N/A
	Road X Slope (%)	N/A	N/A	Clear Space to XWalk (in)	N/A
N/A	Any Obstructions?	N/A	N/A	Storm Grate/Utility Hazard?	N/A
	Obstruction Type			Storm Grate/Utility Type	
		N/A			N/A
			Yes	Surface Condition? (G/P)	Good

Remove & Replace Entire Ramp.
