Access Compliance Report

Public Rights-of-Way

(Curb Ramps)

Intersection ID: 52313	Main Street: LUPINE_CT	Cross Street: SNOWBELL_CT	Location: SE
ADA ID: 1ADCF649023C	Ramp Type: PerpDiag	Initial Pass/Fail: Pass	Overall Compliance: No
Codes/Mitigation Info/Possible Solution			Severity Score: 20
			Field Measurements/Component Compliance

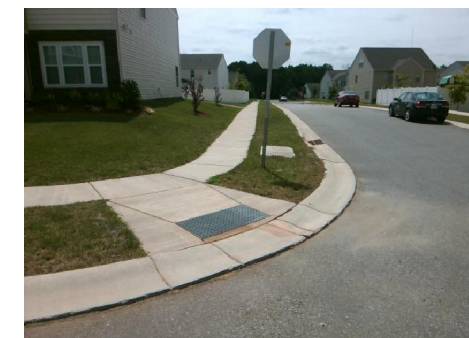
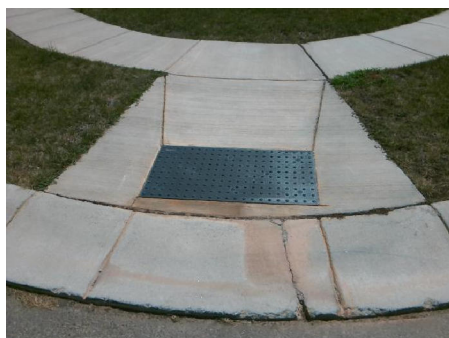
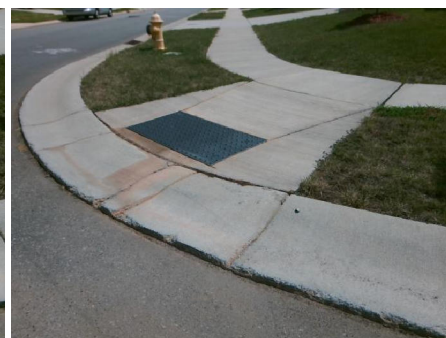
Not Found, R304.5.3, R305.2, R302.7, R302.7.2, R304.5.4

Compliance	Description	Data	Compliance	Description	Data
N/A	Ramp Length (in)	79.0	Yes	Ramp Slope (%)	6.6
Yes	Ramp Width (in)	48.0	Yes	Ramp XSlope (%)	2.0
N/A	Flare Type LT	Sloped	N/A	Flare Type RT	N/A
N/A	Flare Slope LT (%)	0.7	N/A	Flare Slope RT (%)	3.0
N/A	Flare Traversable LT?	No	N/A	Flare Traversable RT?	No
Yes	Landing Length (in)	48.0	Yes	DWS Provided?	Yes
Yes	Landing Width (in)	52.5	Yes	DWS Contrast?	Yes
Yes	Landing Slope (%)	1.9	Yes	DWS Length (in)	24.0
No	Landing X Slope (%)	2.8	Yes	DWS Full Width?	Yes
N/A	Landing Curb? (Y/N)	No	No	DWS Offset (in)	5.0
N/A	Shared Landing?	No			
No	Gutter Ponding?	Yes	No	Gutter Slope (%)	7.3
No	Gutter Lip Ht (in)	2.0	No	Gutter X Slope (%)	2.2
N/A	Painted X Walk1?	No	N/A	Painted X Walk2?	No
	X Walk 1 Direction	To NE		X Walk 2 Direction	To NW
N/A	X Walk 1 Width (in)	N/A	N/A	X Walk 2 Width (in)	N/A
	X Walk 1 Slope (%)	2.6		X Walk 2 Slope (%)	0.8
	X Walk 1 X Slope (%)	3.0		X Walk 2 X Slope (%)	0.1

N/A	Ramp inside XWalk1?	N/A	N/A	Ramp inside XWalk2?	N/A
	Road Slope (%)	0.4	N/A	Clear Space?	Yes
	Road X Slope (%)	0.0	N/A	Clear Space to XWalk (in)	N/A
Yes	Any Obstructions?	No	Yes	Storm Grate/Utility Hazard?	No
	Obstruction Type			Storm Grate/Utility Type	
		N/A			N/A
			Yes	Surface Condition? (G/P)	Good

Remove & Replace Curb Ramp With Two New Directional Ramps or Equivalent. Remove & Replace Gutter.
