Access Compliance Report

Public Rights-of-Way

(Curb Ramps)

Intersection ID: N/A	Main Street: MULLAN_LN	Cross Street: REALTA_DR	Location: SW
ADA ID: 1ADF8F50B478	Ramp Type: Perp	Initial Pass/Fail: Fail	Overall Compliance: No
			Severity Score: 21.25

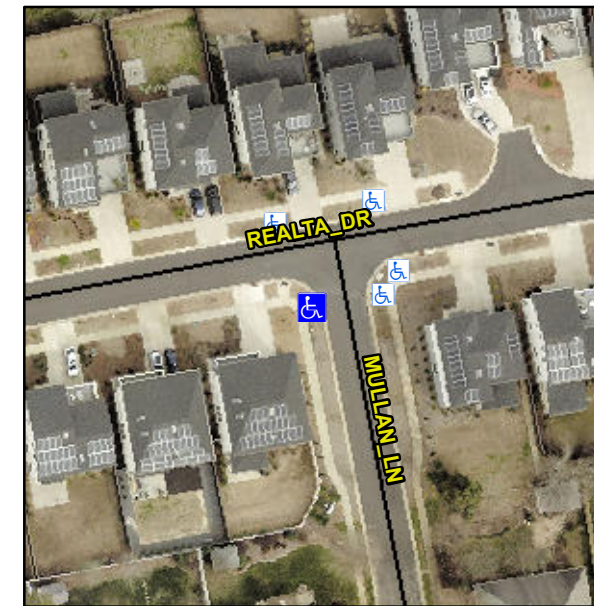
Not Found, R304.5.1, R304.5.3

Compliance	Description	Data	Compliance	Description	Data
N/A	Ramp Length (in)	95.5	Yes	Ramp Slope (%)	5.6
No	Ramp Width (in)	45.0	No	Ramp XSlope (%)	5.7
N/A	Flare Type LT	N/A	N/A	Flare Type RT	N/A
N/A	Flare Slope LT (%)	N/A	N/A	Flare Slope RT (%)	N/A
N/A	Flare Traversable LT?	N/A	N/A	Flare Traversable RT?	N/A
N/A	Landing Length (in)	N/A	N/A	DWS Provided?	N/A
N/A	Landing Width (in)	N/A	N/A	DWS Contrast?	N/A
N/A	Landing Slope (%)	N/A	N/A	DWS Length (in)	N/A
N/A	Landing X Slope (%)	N/A	N/A	DWS Full Width?	N/A
N/A	Landing Curb? (Y/N)	N/A	N/A	DWS Offset (in)	N/A
N/A	Shared Landing?	N/A			
N/A	Gutter Ponding?	N/A	N/A	Gutter Slope (%)	N/A
N/A	Gutter Lip Ht (in)	N/A	N/A	Gutter X Slope (%)	N/A
N/A	Painted X Walk1?	No	N/A	Painted X Walk2?	N/A
	X Walk 1 Direction	To E		X Walk 2 Direction	N/A
N/A	X Walk 1 Width (in)	N/A	N/A	X Walk 2 Width (in)	N/A
	X Walk 1 Slope (%)	4.4		X Walk 2 Slope (%)	N/A
	X Walk 1 X Slope (%)	2.6		X Walk 2 X Slope (%)	N/A

Remove & Replace Entire Ramp.

Total Cost: \$ 1850.00
