Access Compliance Report

Public Rights-of-Way

(Curb Ramps)

Intersection ID: 23772	Main Street: KNIGHTSWOOD_DR	Cross Street: OLD_FORGE_DR	Location: SE
ADA ID: 1ADFE588DFF6	Ramp Type: PerpDiag	Initial Pass/Fail: Fail	Overall Compliance: No
Codes/Mitigation Info/Possible Solution		Field Measurements/Component Compliance	
Severity Score: 22.5

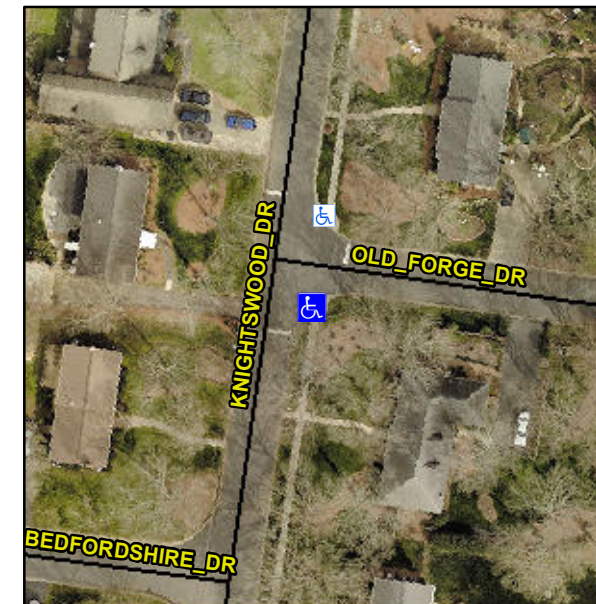
Not Found, R304.5.1, R304.2.2, R304.5.3

Compliance	Description	Data	Compliance	Description	Data
N/A	Ramp Length (in)	73.0	No	Ramp Slope (%)	8.7
No	Ramp Width (in)	47.5	No	Ramp XSlope (%)	4.2
N/A	Flare Type LT	N/A	N/A	Flare Type RT	N/A
N/A	Flare Slope LT (%)	N/A	N/A	Flare Slope RT (%)	N/A
N/A	Flare Traversable LT?	N/A	N/A	Flare Traversable RT?	N/A
N/A	Landing Length (in)	N/A	N/A	DWS Provided?	N/A
N/A	Landing Width (in)	N/A	N/A	DWS Contrast?	N/A
N/A	Landing Slope (%)	N/A	N/A	DWS Length (in)	N/A
N/A	Landing X Slope (%)	N/A	N/A	DWS Full Width?	N/A
N/A	Landing Curb? (Y/N)	N/A	N/A	DWS Offset (in)	N/A
N/A	Shared Landing?	N/A			
N/A	Gutter Ponding?	N/A	N/A	Gutter Slope (%)	N/A
N/A	Gutter Lip Ht (in)	N/A	N/A	Gutter X Slope (%)	N/A
N/A	Painted X Walk1?	No	N/A	Painted X Walk2?	No
	X Walk 1 Direction	To NE		X Walk 2 Direction	To W
N/A	X Walk 1 Width (in)	N/A	N/A	X Walk 2 Width (in)	N/A
	X Walk 1 Slope (%)	0.6		X Walk 2 Slope (%)	3.4
	X Walk 1 X Slope (%)	1.6		X Walk 2 X Slope (%)	2.1

N/A	Ramp inside XWalk1?	N/A	N/A	Ramp inside XWalk2?	N/A
	Road Slope (%)	4.3	N/A	Clear Space?	N/A
	Road X Slope (%)	6.3	N/A	Clear Space to XWalk (in)	N/A
N/A	Any Obstructions?	N/A	N/A	Storm Grate/Utility Hazard?	N/A
	Obstruction Type			Storm Grate/Utility Type	
		N/A			N/A
			Yes	Surface Condition? (G/P)	Good

Remove & Replace Curb Ramp With Two New Directional Ramps or Equivalent.
