# Access Compliance Report

## Public Rights-of-Way

### (Curb Ramps)

| Intersection ID: 45130 | Main Street: DULIN_CREEK_BV | Cross Street: PLAZA_RD_EXT | Location: SW |

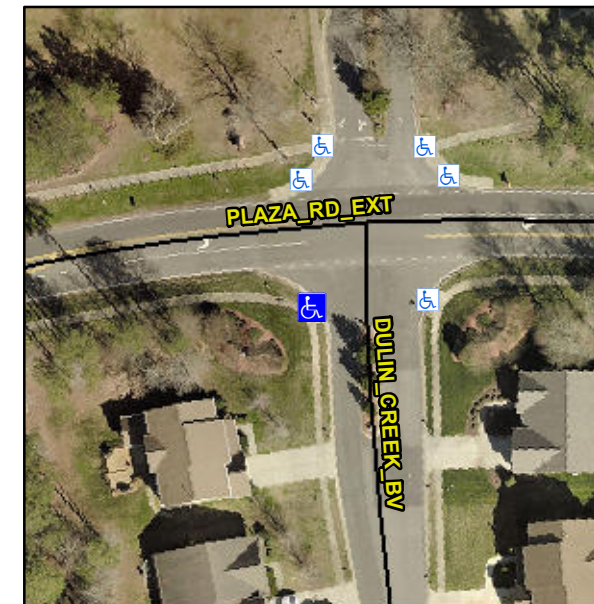
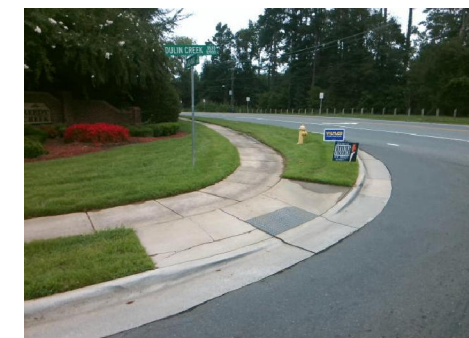
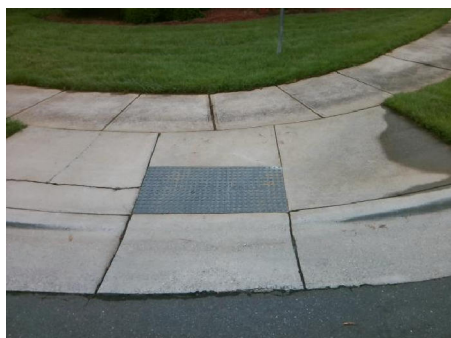
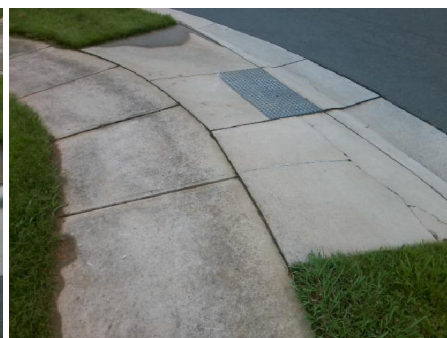
| ADA ID: 1AEB6497C4CA | Ramp Type: PerpDiag | Initial Pass/Fail: Fail | Overall Compliance: No |

**Not Found, R304.5.1, R304.2.2, R304.5.3**

| Compliance | Description | Data | Compliance | Description | Data |
|---|---|---|---|---|---|
| N/A | Ramp Length (in) | 48.0 | No | Ramp Slope (%) | 9.8 |
| No | Ramp Width (in) | 47.0 | No | Ramp XSlope (%) | 3.8 |

**Remove & Replace Curb Ramp With Two New Directional Ramps or Equivalent.**

Total Cost: \$ 3200.00
