# Access Compliance Report

## Public Rights-of-Way

### (Curb Ramps)

| Intersection ID: 29165 | Main Street: BOXELDER_LN | Cross Street: PURPLE_BLOOM_LN | Location: W |

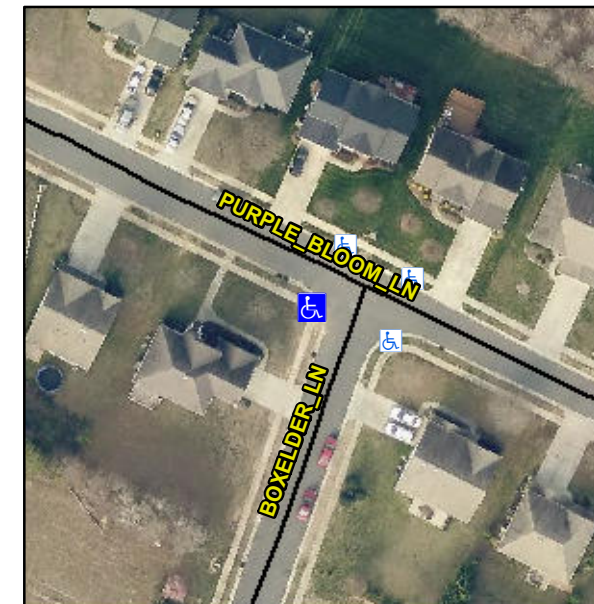
| ADA ID: 1AF3B6F6ED8E | Ramp Type: PerpDiag | Initial Pass/Fail: Fail | Overall Compliance: No |
| Severity Score: 8.75 | | | |

| Compliance | Description | Data | Compliance | Description | Data |
|---|---|---|---|---|---|
| No | Ramp Width (in) | 38.0 | Yes | Ramp XSlope (%) | 1.0 |

**Remove & Replace Curb Ramp With Two New Directional Ramps or Equivalent.**

**R304.5.1**
