# Access Compliance Report

## Public Rights-of-Way

### (Curb Ramps)

Intersection ID: 46489	Main Street: BALLYBAY_DR	Cross Street: TRAILMOOR_RD	Location: NE
ADA ID: 1AF994B3972C	Ramp Type: PerpDiag	Initial Pass/Fail: Fail	Overall Compliance: No
Severity Score: 10			
Codes/Mitigation Info/Possible Solution		Field Measurements/Component Compliance

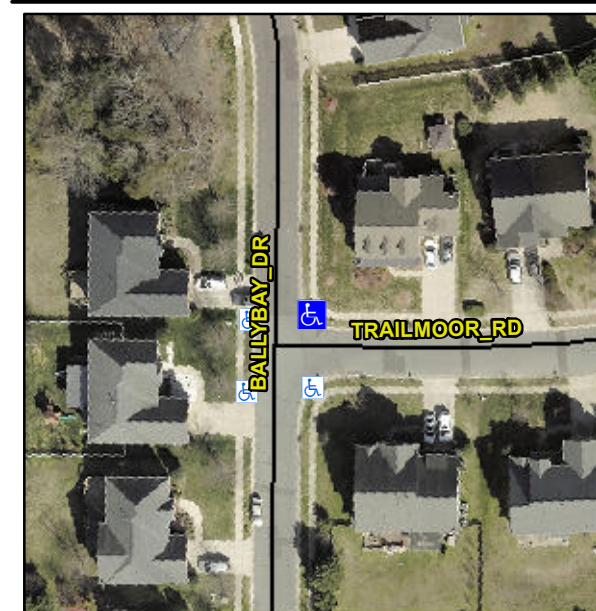
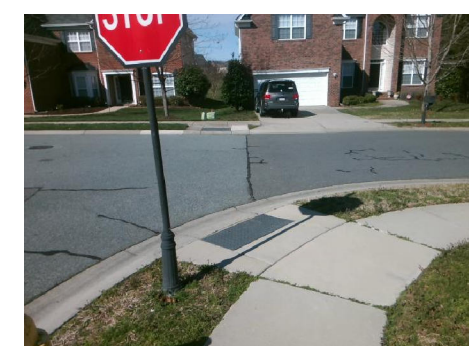
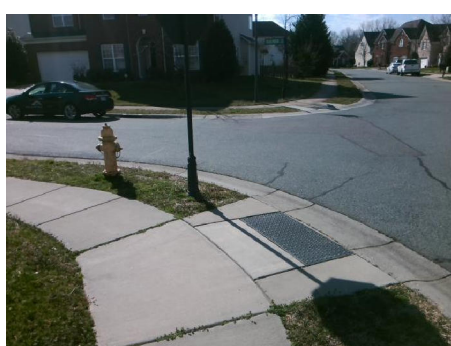
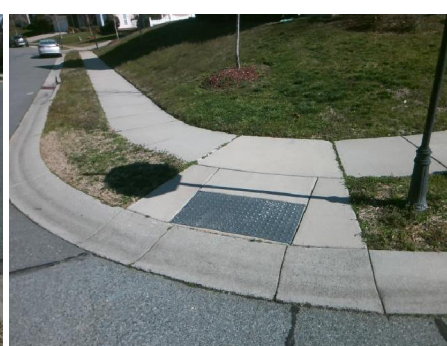
**Not Found, R304.5.1, R304.5.3**

Compliance	Description	Data	Compliance	Description	Data
N/A	Ramp Length (in)	48.0	Yes	Ramp Slope (%)	7.3
No	Ramp Width (in)	44.0	No	Ramp XSlope (%)	2.8
N/A	Flare Type LT	N/A	N/A	Flare Type RT	N/A
N/A	Flare Slope LT (%)	N/A	N/A	Flare Slope RT (%)	N/A
N/A	Flare Traversable LT?	N/A	N/A	Flare Traversable RT?	N/A
N/A	Landing Length (in)	N/A	N/A	DWS Provided?	N/A
N/A	Landing Width (in)	N/A	N/A	DWS Contrast?	N/A
N/A	Landing Slope (%)	N/A	N/A	DWS Length (in)	N/A
N/A	Landing X Slope (%)	N/A	N/A	DWS Full Width?	N/A
N/A	Landing Curb? (Y/N)	N/A	N/A	DWS Offset (in)	N/A
N/A	Shared Landing?	N/A			
N/A	Gutter Ponding?	N/A	N/A	Gutter Slope (%)	N/A
N/A	Gutter Lip Ht (in)	N/A	N/A	Gutter X Slope (%)	N/A
N/A	Painted X Walk1?	No	N/A	Painted X Walk2?	No
	X Walk 1 Direction	To NW		X Walk 2 Direction	To SW
N/A	X Walk 1 Width (in)	N/A	N/A	X Walk 2 Width (in)	N/A
	X Walk 1 Slope (%)	2.4		X Walk 2 Slope (%)	5.3
	X Walk 1 X Slope (%)	4.9		X Walk 2 X Slope (%)	0.5

N/A	Ramp inside XWalk1?	N/A	N/A	Ramp inside XWalk2?	N/A
	Road Slope (%)	0.6	N/A	Clear Space?	N/A
	Road X Slope (%)	5.9	N/A	Clear Space to XWalk (in)	N/A
N/A	Any Obstructions?	N/A	N/A	Storm Grate/Utility Hazard?	N/A
	Obstruction Type			Storm Grate/Utility Type	
		N/A			N/A
		Yes		Surface Condition? (G/P)	Good

**Remove & Replace Curb Ramp With Two New Directional Ramps or Equivalent.**
