# Access Compliance Report

## Public Rights-of-Way

### (Curb Ramps)

| Intersection ID: 49101 | Main Street: PROSPERITY_CROSSING_DR | Cross Street: DOCIA_CROSSING_RD | Location: SW |

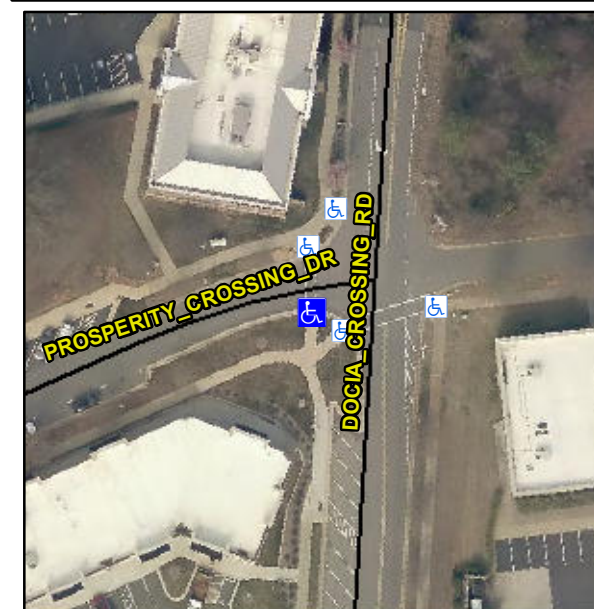
**R305.2, R304.5.3**

| Compliance | Description | Data | Compliance | Description | Data |
|---|---|---|---|---|---|
| N/A | Landing Curb? (Y/N) | No | No | DWS Offset (in) | 5.5 |
| Yes | Gutter Lip Ht (in) | 0.0 | No | Gutter X Slope (%) | 3.8 |

**Remove & Replace Detectable Warning System. Remove & Replace Gutter.**

Total Cost: \$ 1550.00
