Access Compliance Report

Public Rights-of-Way

(Curb Ramps)

Intersection ID: 13604	Main Street: S_MINT_ST	Cross Street: WEST_BV	Location: SW
ADA ID: 1B114C771C43	Ramp Type: PerpDiag	Initial Pass/Fail: Fail	Overall Compliance: No
		Severity Score: 22.5

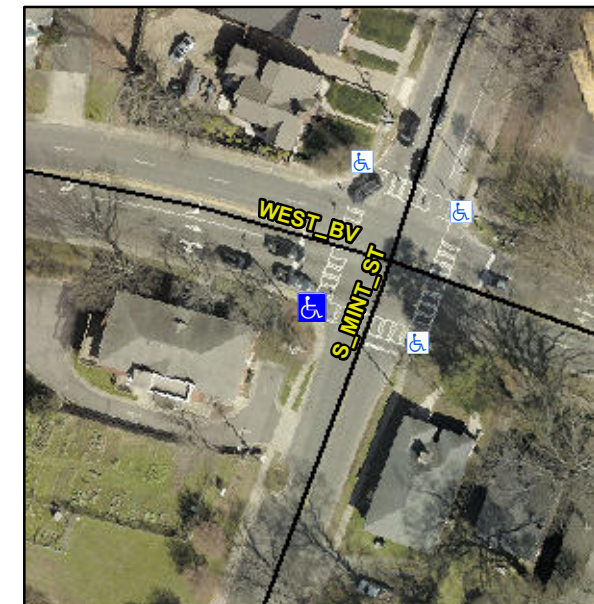
Not Found, R304.5.1, R304.2.2

Compliance	Description	Data	Compliance	Description	Data
N/A	Ramp Length (in)	48.0	No	Ramp Slope (%)	8.6
No	Ramp Width (in)	40.0	Yes	Ramp XSlope (%)	2.4
N/A	Flare Type LT	N/A	N/A	Flare Type RT	N/A
N/A	Flare Slope LT (%)	N/A	N/A	Flare Slope RT (%)	N/A
N/A	Flare Traversable LT?	N/A	N/A	Flare Traversable RT?	N/A
N/A	Landing Length (in)	N/A	N/A	DWS Provided?	N/A
N/A	Landing Width (in)	N/A	N/A	DWS Contrast?	N/A
N/A	Landing Slope (%)	N/A	N/A	DWS Length (in)	N/A
N/A	Landing X Slope (%)	N/A	N/A	DWS Full Width?	N/A
N/A	Landing Curb? (Y/N)	N/A	N/A	DWS Offset (in)	N/A
N/A	Shared Landing?	N/A			
N/A	Gutter Ponding?	N/A	N/A	Gutter Slope (%)	N/A
N/A	Gutter Lip Ht (in)	N/A	N/A	Gutter X Slope (%)	N/A
N/A	Painted X Walk1?	Yes	N/A	Painted X Walk2?	Yes
	X Walk 1 Direction	To SE		X Walk 2 Direction	To NE
N/A	X Walk 1 Width (in)	101.0	N/A	X Walk 2 Width (in)	88.0
	X Walk 1 Slope (%)	4.1		X Walk 2 Slope (%)	1.0
	X Walk 1 X Slope (%)	0.4		X Walk 2 X Slope (%)	4.5

N/A	Ramp inside XWalk1?	Yes	N/A	Ramp inside XWalk2?	Yes
	Road Slope (%)	3.7	N/A	Clear Space?	N/A
	Road X Slope (%)	4.2	N/A	Clear Space to XWalk (in)	N/A
N/A	Any Obstructions?	N/A	N/A	Storm Grate/Utility Hazard?	N/A
	Obstruction Type			Storm Grate/Utility Type	
		N/A			N/A
		Yes		Surface Condition? (G/P)	Good

Remove & Replace Curb Ramp With Two New Directional Ramps or Equivalent.
