Access Compliance Report

Public Rights-of-Way

(Curb Ramps)

Intersection ID: 8329	Main Street: BEATTIES_FORD_RD	Cross Street: LASALLE_ST	Location: NE
ADA ID: 1B18B86961A6	Ramp Type: Perp	Initial Pass/Fail: Fail	Overall Compliance: No
Severity Score: 21.25			
Codes/Mitigation Info/Possible Solution		Field Measurements/Component Compliance

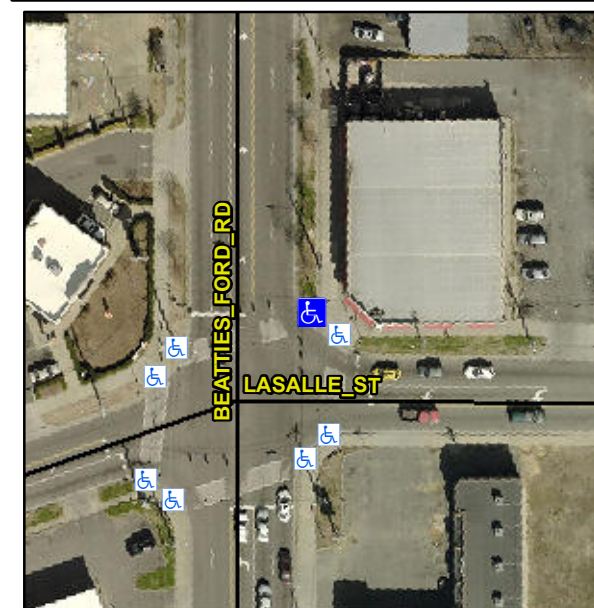
Not Found, R304.5.1, R304.2.2

Compliance	Description	Data	Compliance	Description	Data
N/A	Ramp Length (in)	85.0	No	Ramp Slope (%)	9.0
No	Ramp Width (in)	42.0	Yes	Ramp XSlope (%)	0.5
N/A	Flare Type LT	N/A	N/A	Flare Type RT	N/A
N/A	Flare Slope LT (%)	N/A	N/A	Flare Slope RT (%)	N/A
N/A	Flare Traversable LT?	N/A	N/A	Flare Traversable RT?	N/A
N/A	Landing Length (in)	N/A	N/A	DWS Provided?	N/A
N/A	Landing Width (in)	N/A	N/A	DWS Contrast?	N/A
N/A	Landing Slope (%)	N/A	N/A	DWS Length (in)	N/A
N/A	Landing X Slope (%)	N/A	N/A	DWS Full Width?	N/A
N/A	Landing Curb? (Y/N)	N/A	N/A	DWS Offset (in)	N/A
N/A	Shared Landing?	N/A			
N/A	Gutter Ponding?	N/A	N/A	Gutter Slope (%)	N/A
N/A	Gutter Lip Ht (in)	N/A	N/A	Gutter X Slope (%)	N/A
N/A	Painted X Walk1?	Yes	N/A	Painted X Walk2?	N/A
	X Walk 1 Direction	To SW		X Walk 2 Direction	N/A
N/A	X Walk 1 Width (in)	121.0	N/A	X Walk 2 Width (in)	N/A
	X Walk 1 Slope (%)	0.8		X Walk 2 Slope (%)	N/A
	X Walk 1 X Slope (%)	0.6		X Walk 2 X Slope (%)	N/A

N/A	Ramp inside XWalk1?	Yes	N/A	Ramp inside XWalk2?	N/A
	Road Slope (%)	N/A	N/A	Clear Space?	N/A
	Road X Slope (%)	N/A	N/A	Clear Space to XWalk (in)	N/A
N/A	Any Obstructions?	N/A	N/A	Storm Grate/Utility Hazard?	N/A
	Obstruction Type			Storm Grate/Utility Type	
		N/A			N/A
		Yes		Surface Condition? (G/P)	Good

Possible Solutions:

Remove & Replace Entire Ramp.

Total Cost: \$ 1850.00
