# Access Compliance Report

## Public Rights-of-Way

### (Curb Ramps)

Intersection ID: N/A	Main Street: SAM_NEELY_RD	Cross Street: STEELE_CREEK_RD	Location: NW
ADA ID: 1B19042D07A0	Ramp Type: Perp	Initial Pass/Fail: Fail	Overall Compliance: No
		Severity Score: 12.5

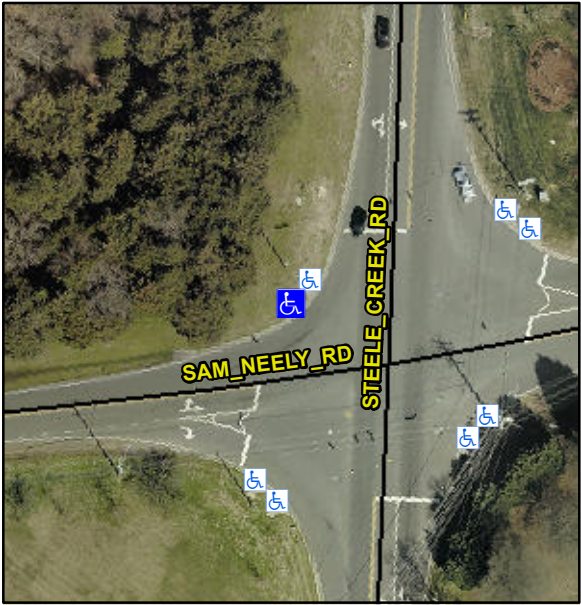
Possible Solutions:		<b>Compliance</b>	<b>Description</b>	<b>Data</b>
	Remove & Replace Entire Ramp.		N/A	Ramp Length (in)	59.0
			Yes	Ramp Width (in)	48.0
			N/A	Flare Type LT	N/A
			N/A	Flare Slope LT (%)	N/A
			N/A	Flare Traversable LT?	N/A
			N/A	Landing Length (in)	N/A
			N/A	Landing Width (in)	N/A
			N/A	Landing Slope (%)	N/A
			N/A	Landing X Slope (%)	N/A
<p>Surveyor Notes:</p> <p>N/A</p> <p>PROW/ADA:</p> <p>Not Found, R304.2.2</p>			N/A	Flare Type RT	N/A
			N/A	Flare Slope RT (%)	N/A
			N/A	Flare Traversable RT?	N/A
			N/A	DWS Provided?	N/A
			N/A	DWS Contrast?	N/A
			N/A	DWS Length (in)	N/A
			N/A	DWS Full Width?	N/A
			N/A	DWS Offset (in)	N/A
			N/A	Shared Landing?	N/A
			N/A	Gutter Ponding?	N/A
			N/A	Gutter Lip Ht (in)	N/A
			N/A	Painted X Walk1?	No
				X Walk 1 Direction	To S
			N/A	X Walk 1 Width (in)	N/A
				X Walk 1 Slope (%)	2.8

X Walk 1 X Slope (%)	2.1
			N/A	Ramp inside XWalk1?	N/A
			N/A	Road Slope (%)	N/A
			N/A	Road X Slope (%)	N/A
			N/A	Any Obstructions?	N/A
				Obstruction Type	
Total Cost:		\$ 1850.00			
			N/A		N/A
			Yes	Surface Condition? (G/P)	Good
