Access Compliance Report Public Rights-of-Way (Curb Ramps)

Intersection ID: 21221 Main Street: SHARON RD Cross Street: SULKIRK_RD Location: SW ADA ID: 1B262287410E Ramp Type: PerpDiag Initial Pass/Fail: Fail **Overall Compliance: No** Severity Score: 33.75

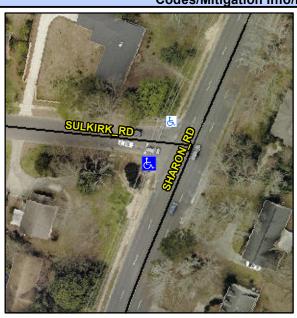
Street 1 Name Stop Condition-Street 2 Street 2 Name Stop Condition-Street 1 **SHARON RD** None **SULKIRK RD** StopSign **Remove & Replace Curb Ramp With** Two New Directional Ramps or Equivalent.

R304.5.3

Not Found, R304.5.1, R304.2.2,

Comp	oliance Description	Data	Comp	liance	Description	Data
N/A	Ramp Length (in)	73.0	No	Ramp	Slope (%)	9.3
No	Ramp Width (in)	36.0	No	Ramp	XSlope (%)	5.5
N/A	Flare Type LT	N/A	N/A	Flare	Type RT	N/A
N/A	Flare Slope LT (%)	N/A	N/A	Flare	Slope RT (%)	N/A
N/A	Flare Traversable LT?	N/A	N/A	Flare	Traversable RT?	N/A
N/A	Landing Length (in)	N/A	N/A	DWS	Provided?	N/A
N/A	Landing Width (in)	N/A	N/A	DWS	Contrast?	N/A
N/A	Landing Slope (%)	N/A	N/A	DWS	Length (in)	N/A
N/A	Landing X Slope (%)	N/A	N/A	DWS	Full Width?	N/A
N/A	Landing Curb? (Y/N)	N/A	N/A	DWS	Offset (in)	N/A
N/A	Shared Landing?	N/A				
N/A	Gutter Ponding?	N/A	N/A	Gutte	r Slope (%)	N/A
N/A	Gutter Lip Ht (in)	N/A	N/A	Gutte	r X Slope (%)	N/A
N/A	Painted X Walk1?	No	N/A	Paint	ed X Walk2?	No
	X Walk 1 Direction	To SE		X Wa	lk 2 Direction	To NE
N/A	X Walk 1 Width (in)	N/A	N/A	X Wa	lk 2 Width (in)	N/A
	X Walk 1 Slope (%)	2.9		X Wa	lk 2 Slope (%)	5.7
	X Walk 1 X Slope (%)	6.2		X Wa	lk 2 X Slope (%)	1.3

N/A	Ramp inside XWalk1?	N/A	N/A	Ramp	inside XWalk2?	N/A
	Road Slope (%)	2.4	N/A	Clear	Space?	N/A
	Road X Slope (%)	3.7	N/A	Clear	Space to XWalk (in)	N/A
N/A	Any Obstructions?	N/A	N/A	Storm	Grate/Utility Hazard?	N/A
	Obstruction Type			Storm	Grate/Utility Type	
		N/A				N/A

Total Cost: 3200.00
