Access Compliance Report

Public Rights-of-Way

(Curb Ramps)

Intersection ID: 10034320	Main Street: PERIMETER_PY	Cross Street: N/A	Location: NW
ADA ID: 1B2A022D7125	Ramp Type: Perp	Initial Pass/Fail: Fail	Overall Compliance: No
Severity Score: 10			
Codes/Mitigation Info/Possible Solution		Field Measurements/Component Compliance

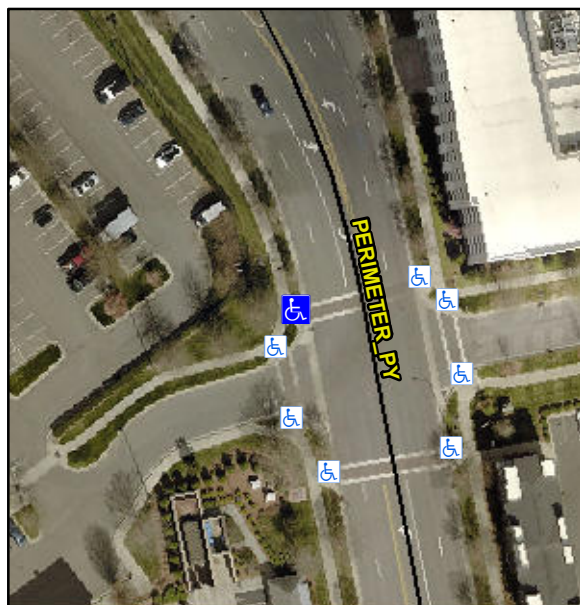
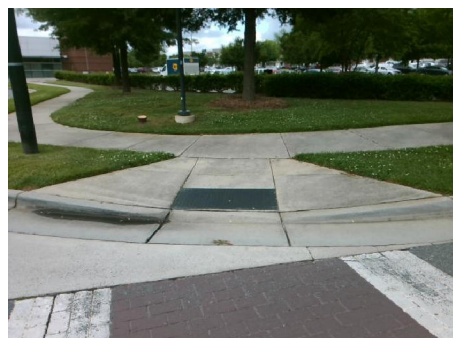
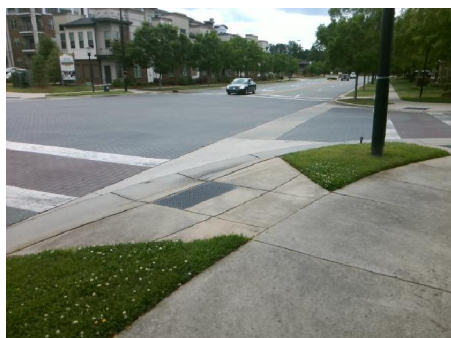
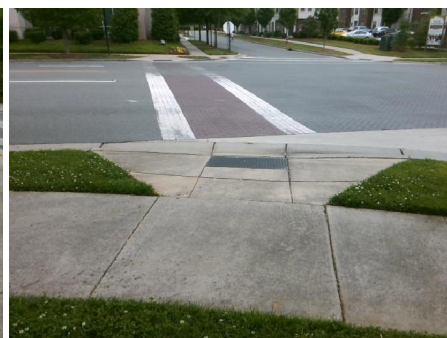
Not Found, R304.5.1, R304.5.3

Compliance	Description	Data	Compliance	Description	Data
N/A	Ramp Length (in)	46.0	Yes	Ramp Slope (%)	7.4
No	Ramp Width (in)	47.0	No	Ramp XSlope (%)	2.2
N/A	Flare Type LT	N/A	N/A	Flare Type RT	N/A
N/A	Flare Slope LT (%)	N/A	N/A	Flare Slope RT (%)	N/A
N/A	Flare Traversable LT?	N/A	N/A	Flare Traversable RT?	N/A
N/A	Landing Length (in)	N/A	N/A	DWS Provided?	N/A
N/A	Landing Width (in)	N/A	N/A	DWS Contrast?	N/A
N/A	Landing Slope (%)	N/A	N/A	DWS Length (in)	N/A
N/A	Landing X Slope (%)	N/A	N/A	DWS Full Width?	N/A
N/A	Landing Curb? (Y/N)	N/A	N/A	DWS Offset (in)	N/A
N/A	Shared Landing?	N/A			
N/A	Gutter Ponding?	N/A	N/A	Gutter Slope (%)	N/A
N/A	Gutter Lip Ht (in)	N/A	N/A	Gutter X Slope (%)	N/A
N/A	Painted X Walk1?	Yes	N/A	Painted X Walk2?	N/A
	X Walk 1 Direction	To E		X Walk 2 Direction	N/A
N/A	X Walk 1 Width (in)	72.0	N/A	X Walk 2 Width (in)	N/A
	X Walk 1 Slope (%)	4.1		X Walk 2 Slope (%)	N/A
	X Walk 1 X Slope (%)	2.1		X Walk 2 X Slope (%)	N/A

N/A	Ramp inside XWalk1?	Yes	N/A	Ramp inside XWalk2?	N/A
	Road Slope (%)	N/A	N/A	Clear Space?	N/A
	Road X Slope (%)	N/A	N/A	Clear Space to XWalk (in)	N/A
N/A	Any Obstructions?	N/A	N/A	Storm Grate/Utility Hazard?	N/A
	Obstruction Type			Storm Grate/Utility Type	
		N/A			N/A
		Yes		Surface Condition? (G/P)	Good

Remove & Replace Entire Ramp.
