# Access Compliance Report

## Public Rights-of-Way

### (Curb Ramps)

| Intersection ID: 13402 | Main Street: S_MINT_ST | Cross Street: SPRUCE_ST | Location: N |

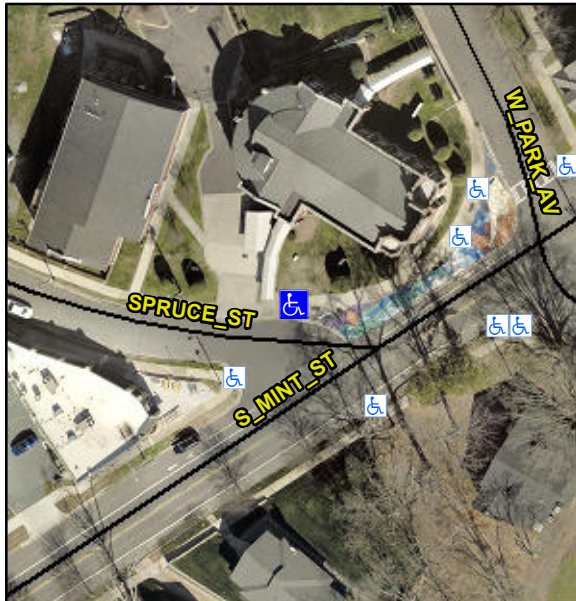
**LT SL < 5%**

**R304.5.3, R304.2.2-Perp, R304.3.2-Para, R302.7.2**

| Compliance | Description | Data | Compliance | Description | Data |
|---|---|---|---|---|---|
| No | Ramp XSlope LT (%) | 2.1 | No | Ramp XSlope RT (%) | 2.7 |
| No | Landing Slope (%) | 2.1 | Yes | DWS Length (in) | 24.0 |
| No | Gutter Lip Ht (in) | 1.0 | Yes | Gutter X Slope (%) | 0.3 |

**Remove & Replace Curb Ramp With Two New Directional Ramps or Equivalent. Grind Gutter Lip.**
