Access Compliance Report

Public Rights-of-Way

(Curb Ramps)

Intersection ID: N/A	Main Street: REGAL_ESTATE_LN	Cross Street: WILORA_LAKE_RD	Location: SE
ADA ID: 1B397F2478E4	Ramp Type: PerpDiag	Initial Pass/Fail: Fail	Overall Compliance: No
Severity Score: 8.75			
Codes/Mitigation Info/Possible Solution		Field Measurements/Component Compliance

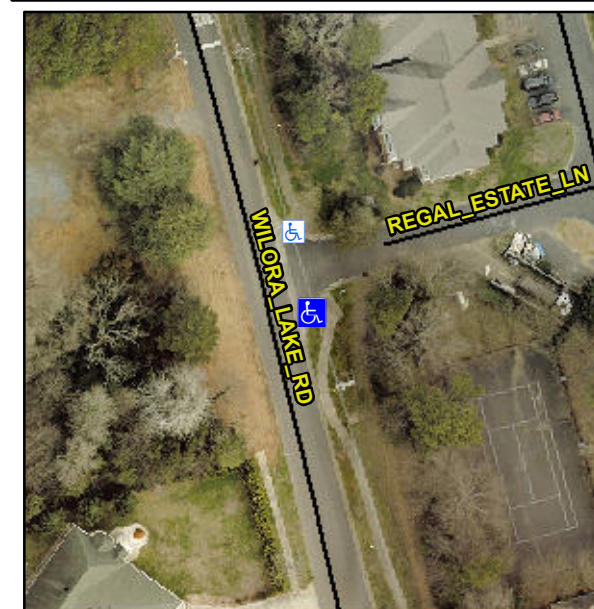
Compliance	Description	Data	Compliance	Description	Data
N/A	Ramp Length (in)	103.0	Yes	Ramp Slope (%)	6.0
No	Ramp Width (in)	46.0	Yes	Ramp XSlope (%)	1.6
N/A	Flare Type LT	N/A	N/A	Flare Type RT	N/A
N/A	Flare Slope LT (%)	N/A	N/A	Flare Slope RT (%)	N/A
N/A	Flare Traversable LT?	N/A	N/A	Flare Traversable RT?	N/A
N/A	Landing Length (in)	N/A	N/A	DWS Provided?	N/A
N/A	Landing Width (in)	N/A	N/A	DWS Contrast?	N/A
N/A	Landing Slope (%)	N/A	N/A	DWS Length (in)	N/A
N/A	Landing X Slope (%)	N/A	N/A	DWS Full Width?	N/A
N/A	Landing Curb? (Y/N)	N/A	N/A	DWS Offset (in)	N/A
N/A	Shared Landing?	N/A			
N/A	Gutter Ponding?	N/A	N/A	Gutter Slope (%)	N/A
N/A	Gutter Lip Ht (in)	N/A	N/A	Gutter X Slope (%)	N/A
N/A	Painted X Walk1?	No	N/A	Painted X Walk2?	No
	X Walk 1 Direction	To N		X Walk 2 Direction	To W
N/A	X Walk 1 Width (in)	N/A	N/A	X Walk 2 Width (in)	N/A
	X Walk 1 Slope (%)	1.4		X Walk 2 Slope (%)	0.8
	X Walk 1 X Slope (%)	0.5		X Walk 2 X Slope (%)	2.4

N/A	Ramp inside XWalk1?	N/A	N/A	Ramp inside XWalk2?	N/A
	Road Slope (%)	1.0	N/A	Clear Space?	N/A
	Road X Slope (%)	3.2	N/A	Clear Space to XWalk (in)	N/A
N/A	Any Obstructions?	N/A	N/A	Storm Grate/Utility Hazard?	N/A
	Obstruction Type			Storm Grate/Utility Type	
		N/A			N/A
		Yes		Surface Condition? (G/P)	Good

Possible Solutions:

Remove & Replace Curb Ramp With Two New Directional Ramps or Equivalent.

R304.5.1
