# Access Compliance Report

## Public Rights-of-Way

### (Curb Ramps)

| Intersection ID: 16310 | Main Street: LYNNVILLE_AV | Cross Street: N_SHARON_AMITY_RD | Location: NW |

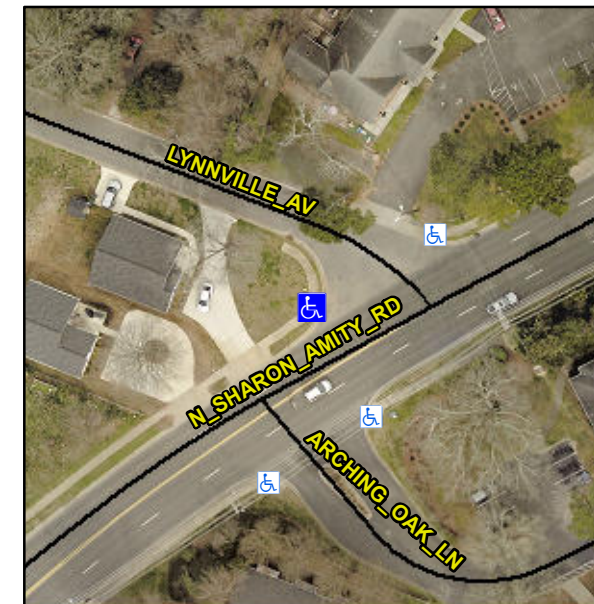
**RT RP < 5%**

| Compliance | Description | Data | Compliance | Description | Data |
|---|---|---|---|---|---|
| No | Ramp XSlope LT (%) | 3.7 | No | Ramp XSlope RT (%) | 2.7 |
| No | Landing Width (in) | 35.0 | N/A | DWS Contrast? | No |
| No | Landing Slope (%) | 3.0 | N/A | DWS Length (in) | N/A |
| No | Gutter Ponding? | Yes | Yes | Gutter Slope (%) | 1.5 |

**Remove & Replace Curb Ramp With Two New Directional Ramps or Equivalent. Gutter Ponding Observed.**

**R304.5.3, R304.2.1, R304.2.2-Perp, R304.3.2-Para, R305, R302.7**
