Access Compliance Report

Public Rights-of-Way

(Curb Ramps)

Intersection ID: 24170	Main Street: CARMEL_RD	Cross Street: FOXMOOR_DR	Location: SW
ADA ID: 1B3DAD60D1B9	Ramp Type: Perp	Initial Pass/Fail: Fail	Overall Compliance: No
Severity Score: 22.5			
Codes/Mitigation Info/Possible Solution		Field Measurements/Component Compliance

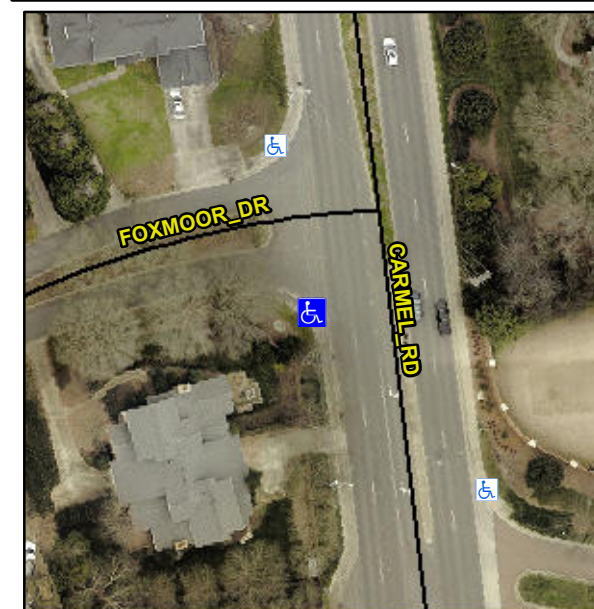
R304.5.1, R304.2.2, R304.5.3

Compliance	Description	Data	Compliance	Description	Data
N/A	Ramp Length (in)	60.0	No	Ramp Slope (%)	10.1
No	Ramp Width (in)	42.0	No	Ramp XSlope (%)	3.8
N/A	Flare Type LT	N/A	N/A	Flare Type RT	N/A
N/A	Flare Slope LT (%)	N/A	N/A	Flare Slope RT (%)	N/A
N/A	Flare Traversable LT?	N/A	N/A	Flare Traversable RT?	N/A
N/A	Landing Length (in)	N/A	N/A	DWS Provided?	N/A
N/A	Landing Width (in)	N/A	N/A	DWS Contrast?	N/A
N/A	Landing Slope (%)	N/A	N/A	DWS Length (in)	N/A
N/A	Landing X Slope (%)	N/A	N/A	DWS Full Width?	N/A
N/A	Landing Curb? (Y/N)	N/A	N/A	DWS Offset (in)	N/A
N/A	Shared Landing?	N/A			
N/A	Gutter Ponding?	N/A	N/A	Gutter Slope (%)	N/A
N/A	Gutter Lip Ht (in)	N/A	N/A	Gutter X Slope (%)	N/A
N/A	Painted X Walk1?	No	N/A	Painted X Walk2?	N/A
	X Walk 1 Direction	To N		X Walk 2 Direction	N/A
N/A	X Walk 1 Width (in)	N/A	N/A	X Walk 2 Width (in)	N/A
	X Walk 1 Slope (%)	2.2		X Walk 2 Slope (%)	N/A
	X Walk 1 X Slope (%)	3.4		X Walk 2 X Slope (%)	N/A

Possible Solutions:

Remove & Replace Entire Ramp.

Total Cost: \$ 1850.00
