Access Compliance Report

Public Rights-of-Way

(Curb Ramps)

Intersection ID: 31619	Main Street: DEREK CHRISTOPHER CT	Cross Street: MARIA CHRISTINA LN	Location: NE
ADA ID: 1B4120464F5D	Ramp Type: PerpDiag	Initial Pass/Fail: Fail	Overall Compliance: No
		Severity Score: 8.75

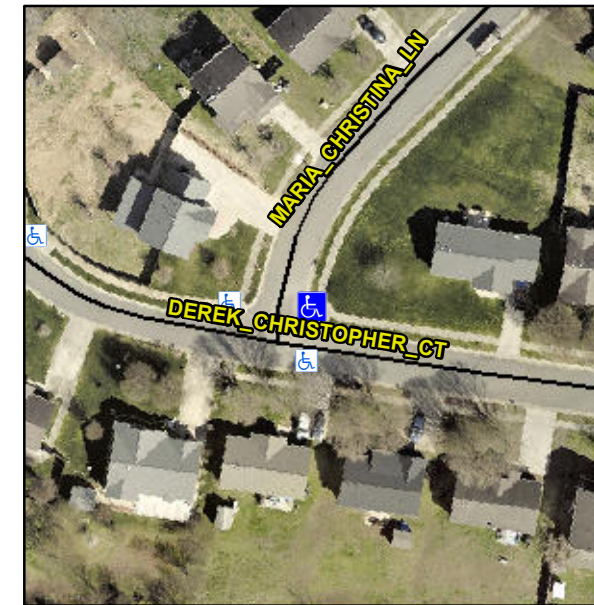
Compliance	Description	Data	Compliance	Description	Data
N/A	Ramp Length (in)	52.5	Yes	Ramp Slope (%)	7.3
No	Ramp Width (in)	39.5	Yes	Ramp XSlope (%)	2.0
N/A	Flare Type LT	N/A	N/A	Flare Type RT	N/A
N/A	Flare Slope LT (%)	N/A	N/A	Flare Slope RT (%)	N/A
N/A	Flare Traversable LT?	N/A	N/A	Flare Traversable RT?	N/A
N/A	Landing Length (in)	N/A	N/A	DWS Provided?	N/A
N/A	Landing Width (in)	N/A	N/A	DWS Contrast?	N/A
N/A	Landing Slope (%)	N/A	N/A	DWS Length (in)	N/A
N/A	Landing X Slope (%)	N/A	N/A	DWS Full Width?	N/A
N/A	Landing Curb? (Y/N)	N/A	N/A	DWS Offset (in)	N/A
N/A	Shared Landing?	N/A			
N/A	Gutter Ponding?	N/A	N/A	Gutter Slope (%)	N/A
N/A	Gutter Lip Ht (in)	0.5	N/A	Gutter X Slope (%)	N/A
N/A	Painted X Walk1?	No	N/A	Painted X Walk2?	No
	X Walk 1 Direction	To W		X Walk 2 Direction	To S
N/A	X Walk 1 Width (in)	N/A	N/A	X Walk 2 Width (in)	N/A
	X Walk 1 Slope (%)	0.6		X Walk 2 Slope (%)	0.5
	X Walk 1 X Slope (%)	3.1		X Walk 2 X Slope (%)	1.9

N/A	Ramp inside XWalk1?	N/A	N/A	Ramp inside XWalk2?	N/A
	Road Slope (%)	0.9	N/A	Clear Space?	N/A
	Road X Slope (%)	0.7	N/A	Clear Space to XWalk (in)	N/A
N/A	Any Obstructions?	N/A	N/A	Storm Grate/Utility Hazard?	N/A
	Obstruction Type			Storm Grate/Utility Type	
		N/A			N/A
			Yes	Surface Condition? (G/P)	Good

Possible Solutions:

Remove & Replace Curb Ramp With Two New Directional Ramps or Equivalent.

R304.5.1
