Access Compliance Report

Public Rights-of-Way

(Curb Ramps)

Intersection ID: 20056	Main Street: COLONY_RD	Cross Street: GOVERNORS_HILL_LN	Location: SW
ADA ID: 1B54A4D50F73	Ramp Type: Directional1	Initial Pass/Fail: Fail	Overall Compliance: No
Codes/Mitigation Info/Possible Solution		Field Measurements/Component Compliance	
Severity Score: 25

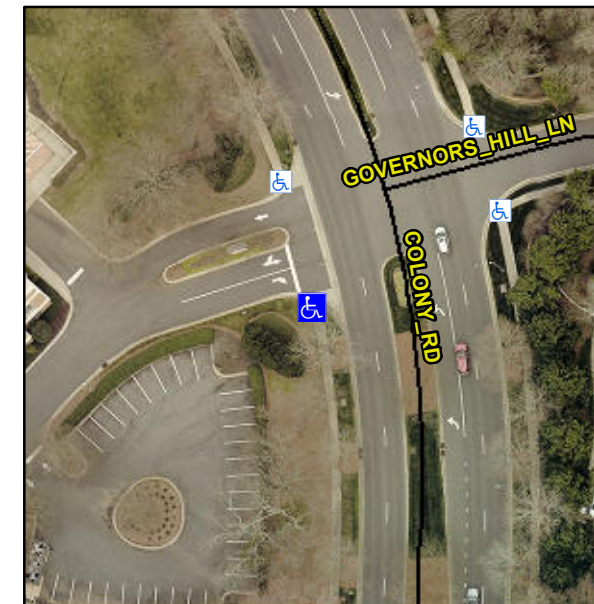
R304.2.2, R304.5.3

Compliance	Description	Data	Compliance	Description	Data
N/A	Ramp Length (in)	60.0	N/A	Grade Break?	N/A
Yes	Ramp Width (in)	61.0	N/A	Grade Break Slope (%)	0.0
No	Ramp Slope (%)	9.6	N/A	Grade Break XSlope (%)	0.0
No	Ramp XSlope (%)	5.5			
N/A	Flare Type LT	N/A	N/A	Flare Type RT	N/A
N/A	Flare Slope LT (%)	N/A	N/A	Flare Slope RT (%)	0.0
N/A	Flare Traversable LT?	N/A	N/A	Flare Traversable RT?	N/A
N/A	Landing Length (in)	0.0	N/A	DWS Provided?	N/A
N/A	Landing Width (in)	0.0	N/A	DWS Contrast?	N/A
N/A	Landing Slope (%)	0.0	N/A	DWS Length (in)	N/A
N/A	Landing X Slope (%)	0.0	N/A	DWS Full Width?	N/A
N/A	Landing Curb? (Y/N)	N/A	N/A	DWS Offset LT (in)	N/A
N/A	Shared Landing?	N/A	N/A	DWS Offset RT (in)	N/A
N/A	Gutter Ponding?	0.0	N/A	Gutter Slope (%)	N/A
N/A	Gutter Lip Ht (in)	0.0	N/A	Gutter X Slope (%)	N/A
N/A	Painted X Walk1?	No		Road Slope (%)	4.9
	X Walk 1 Direction	To NW		Road X Slope (%)	3.3
	X Walk 1 Width (in)	N/A		Clear Space?	N/A

X Walk 1 Slope (%)	4.9	N/A	Clear Space to XWalk (in)	N/A
	X Walk 1 X Slope (%)	3.3	N/A	Storm Grate/Utility Hazard?	N/A
N/A	Ramp inside XWalk1?	N/A		Storm Grate/Utility Type	
N/A	Any Obstructions?	N/A			N/A
	Obstruction Type		Yes	Surface Condition? (G/P)	Good
			N/A	Curb Slope (%)	8.2

Possible Solutions:

Remove & Replace Entire Ramp.
