# Access Compliance Report

## Public Rights-of-Way

### (Curb Ramps)

| Intersection ID: 43360 | Main Street: HIGHLAND_COMMONS_RD | Cross Street: RIDGEVIEW_COMMONS_DR | Location: W |

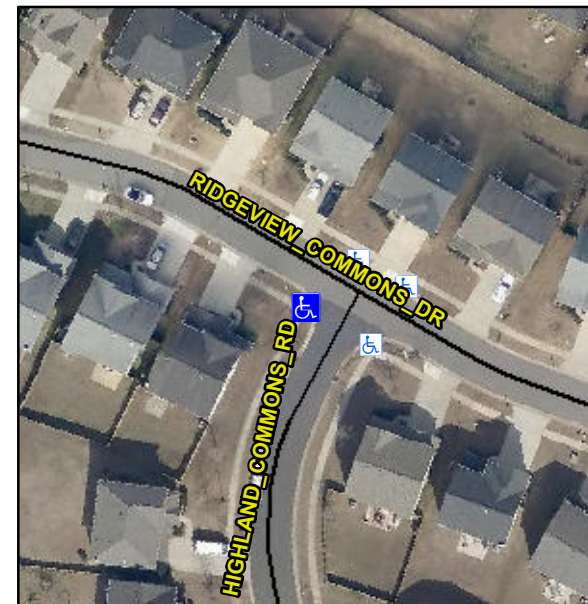
| Severity Score: 15.25 | | | |

**Not Found, R304.5.3, R304.2.1, R305.2, R302.7.2**

| Compliance | Description | Data | Compliance | Description | Data |
|---|---|---|---|---|---|
| Yes | Ramp Width (in) | 48.0 | No | Ramp XSlope (%) | 3.2 |
| No | Landing Width (in) | 43.0 | Yes | DWS Contrast? | Yes |
| No | Landing X Slope (%) | 4.3 | Yes | DWS Full Width? | Yes |
| No | Gutter Lip Ht (in) | 1.0 | No | Gutter X Slope (%) | 3.5 |

Possible Solutions:

**Remove & Replace Curb Ramp With Two New Directional Ramps or Equivalent. Remove & Replace Gutter.**
