# Access Compliance Report

## Public Rights-of-Way

### (Curb Ramps)

| Intersection ID: 14851 | Main Street: E_WORTHINGTON_AV | Cross Street: PARK_RD | Location: | N |

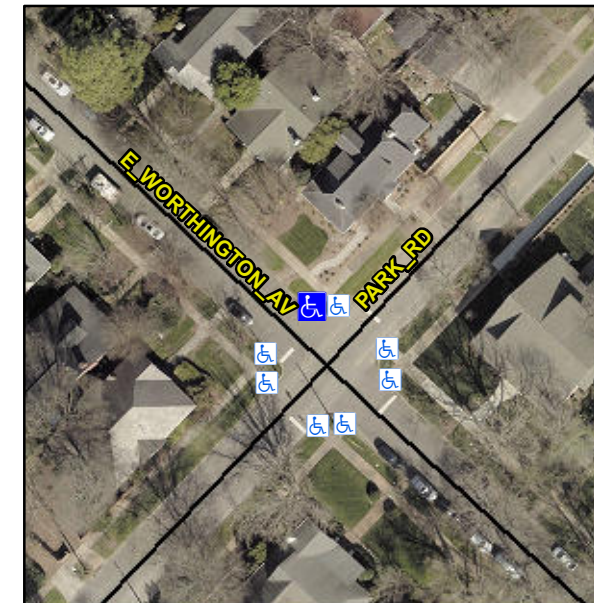
| ADA ID: 1B5B919CE745 | Ramp Type: Directional1 | Initial Pass/Fail: Fail | Overall Compliance: No | Severity Score: 1.25 |

**R304.5.3**

| Compliance | Description | Data | Compliance | Description | Data |
|---|---|---|---|---|---|
| No | Ramp XSlope (%) | 2.3 | | | |

**Remove & Replace Entire Ramp.**
