# Access Compliance Report

## Public Rights-of-Way

### (Curb Ramps)

Intersection ID: 6850	Main Street: BEARWALLOW_CT	Cross Street: WINGDALE_DR	Location:	N
ADA ID: 1B5F57CC63C2	Ramp Type: Perp	Initial Pass/Fail: Fail	Overall Compliance: No	Severity Score: 10

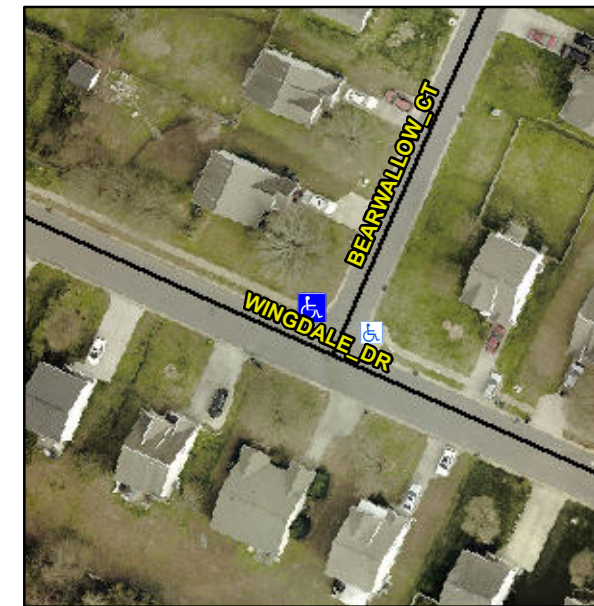
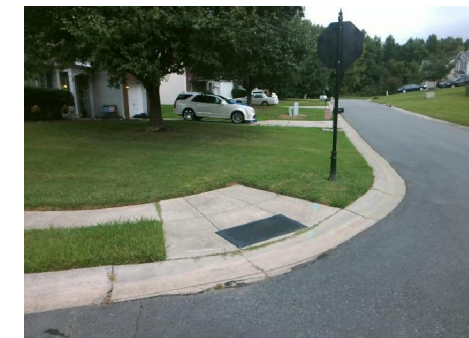
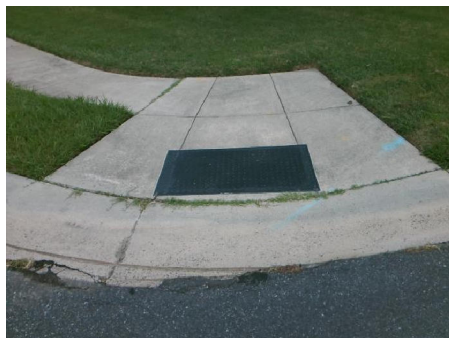
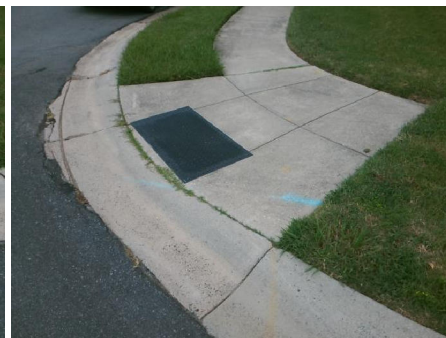
**Not Found, R304.5.1, R304.5.3**

Compliance	Description	Data	Compliance	Description	Data
N/A	Ramp Length (in)	52.0	Yes	Ramp Slope (%)	6.6
No	Ramp Width (in)	36.5	No	Ramp XSlope (%)	4.5
N/A	Flare Type LT	N/A	N/A	Flare Type RT	N/A
N/A	Flare Slope LT (%)	N/A	N/A	Flare Slope RT (%)	N/A
N/A	Flare Traversable LT?	N/A	N/A	Flare Traversable RT?	N/A
N/A	Landing Length (in)	N/A	N/A	DWS Provided?	N/A
N/A	Landing Width (in)	N/A	N/A	DWS Contrast?	N/A
N/A	Landing Slope (%)	N/A	N/A	DWS Length (in)	N/A
N/A	Landing X Slope (%)	N/A	N/A	DWS Full Width?	N/A
N/A	Landing Curb? (Y/N)	N/A	N/A	DWS Offset (in)	N/A
N/A	Shared Landing?	N/A			
N/A	Gutter Ponding?	N/A	N/A	Gutter Slope (%)	N/A
N/A	Gutter Lip Ht (in)	0.5	N/A	Gutter X Slope (%)	N/A
N/A	Painted X Walk1?	No	N/A	Painted X Walk2?	N/A
	X Walk 1 Direction	To SE		X Walk 2 Direction	N/A
N/A	X Walk 1 Width (in)	N/A	N/A	X Walk 2 Width (in)	N/A
	X Walk 1 Slope (%)	3.5		X Walk 2 Slope (%)	N/A
	X Walk 1 X Slope (%)	0.7		X Walk 2 X Slope (%)	N/A

N/A	Ramp inside XWalk1?	N/A	N/A	Ramp inside XWalk2?	N/A
	Road Slope (%)	N/A	N/A	Clear Space?	N/A
	Road X Slope (%)	N/A	N/A	Clear Space to XWalk (in)	N/A
N/A	Any Obstructions?	N/A	N/A	Storm Grate/Utility Hazard?	N/A
	Obstruction Type			Storm Grate/Utility Type	
		N/A			N/A
			Yes	Surface Condition? (G/P)	Good

**Remove & Replace Entire Ramp.**
