Access Compliance Report

Public Rights-of-Way

(Curb Ramps)

Intersection ID: 48600	Main Street: GRANDIFLORA_DR	Cross Street: N/A	Location: NE
ADA ID: 1B63EBD07976	Ramp Type: Perp	Initial Pass/Fail: Fail	Overall Compliance: No
Severity Score: 10			
Codes/Mitigation Info/Possible Solution		Field Measurements/Component Compliance

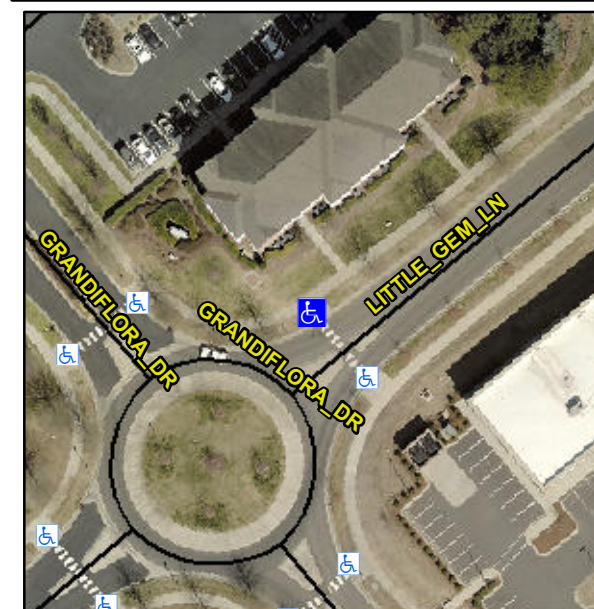
Not Found, R304.5.1, R304.5.3

Compliance	Description	Data	Compliance	Description	Data
N/A	Ramp Length (in)	95.0	Yes	Ramp Slope (%)	5.1
No	Ramp Width (in)	47.0	No	Ramp XSlope (%)	3.9
N/A	Flare Type LT	N/A	N/A	Flare Type RT	N/A
N/A	Flare Slope LT (%)	N/A	N/A	Flare Slope RT (%)	N/A
N/A	Flare Traversable LT?	N/A	N/A	Flare Traversable RT?	N/A
N/A	Landing Length (in)	N/A	N/A	DWS Provided?	N/A
N/A	Landing Width (in)	N/A	N/A	DWS Contrast?	N/A
N/A	Landing Slope (%)	N/A	N/A	DWS Length (in)	N/A
N/A	Landing X Slope (%)	N/A	N/A	DWS Full Width?	N/A
N/A	Landing Curb? (Y/N)	N/A	N/A	DWS Offset (in)	N/A
N/A	Shared Landing?	N/A			
N/A	Gutter Ponding?	N/A	N/A	Gutter Slope (%)	N/A
N/A	Gutter Lip Ht (in)	N/A	N/A	Gutter X Slope (%)	N/A
N/A	Painted X Walk1?	Yes	N/A	Painted X Walk2?	N/A
	X Walk 1 Direction	To SE		X Walk 2 Direction	N/A
N/A	X Walk 1 Width (in)	54.0	N/A	X Walk 2 Width (in)	N/A
	X Walk 1 Slope (%)	1.6		X Walk 2 Slope (%)	N/A
	X Walk 1 X Slope (%)	2.8		X Walk 2 X Slope (%)	N/A

Remove & Replace Entire Ramp.
