# Access Compliance Report

## Public Rights-of-Way

### (Curb Ramps)

| Intersection ID: 48438 | Main Street: BARRANDS_LN | Cross Street: LATHERTON_LN | Location: SE |

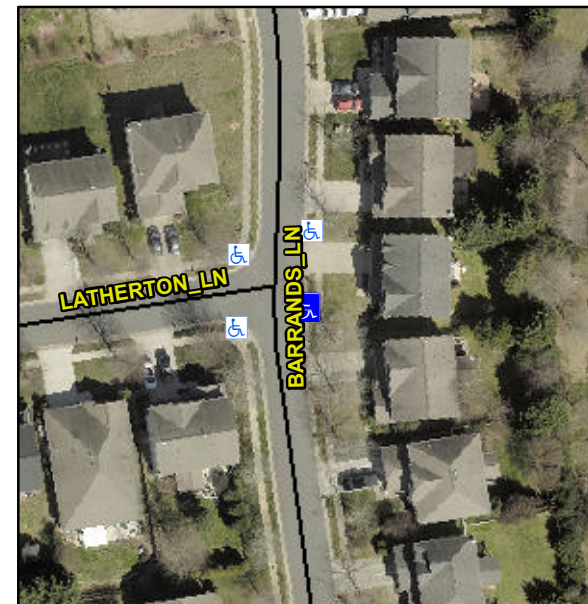
| ADA ID: 1B6DB6D42090 | Ramp Type: Perp | Initial Pass/Fail: Pass | Overall Compliance: No |
| Severity Score: 5 | | | |

| Compliance | Description | Data | Compliance | Description | Data |
|---|---|---|---|---|---|
| No | Landing Length (in) | 47.0 | Yes | DWS Provided? | Yes |
| Yes | Gutter Ponding? | No | No | Gutter Slope (%) | 9.6 |

**Remove & Replace Landing.  
Remove & Replace Gutter.**

**R304.2.1, R304.5.4**

Total Cost: \$ 1250.00
