# Access Compliance Report

## Public Rights-of-Way

### (Curb Ramps)

Intersection ID: 23951	Main Street: S_TRYON_ST	Cross Street: CHOATE_CR	Location: SE
ADA ID: 1B802B6B3D09	Ramp Type: Perp	Initial Pass/Fail: Pass	Overall Compliance: No
Severity Score: 22.5			
Codes/Mitigation Info/Possible Solution		Field Measurements/Component Compliance

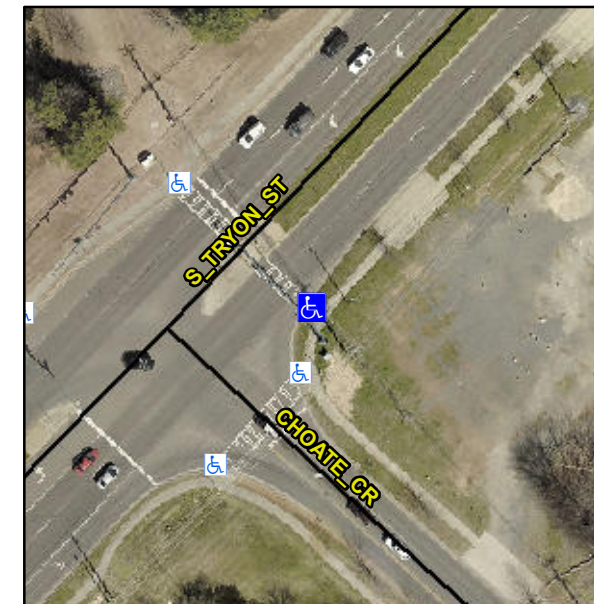
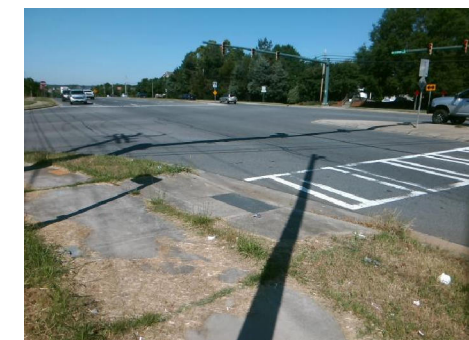
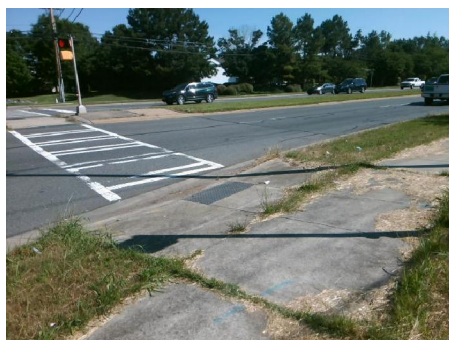
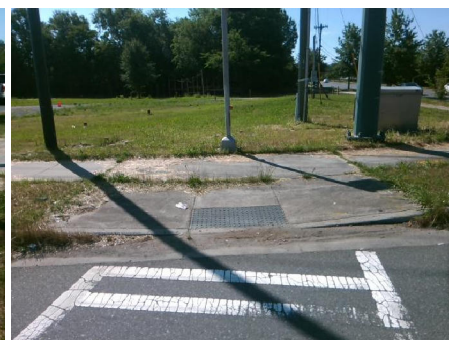
Compliance	Description	Data	Compliance	Description	Data
N/A	Ramp Length (in)	136.0	Yes	Ramp Slope (%)	6.7
Yes	Ramp Width (in)	48.0	Yes	Ramp XSlope (%)	1.1
N/A	Flare Type LT	Sloped	N/A	Flare Type RT	N/A
N/A	Flare Slope LT (%)	5.8	N/A	Flare Slope RT (%)	6.3
N/A	Flare Traversable LT?	No	N/A	Flare Traversable RT?	No
No	Landing Length (in)	N/A	Yes	DWS Provided?	Yes
No	Landing Width (in)	N/A	Yes	DWS Contrast?	Yes
No	Landing Slope (%)	N/A	Yes	DWS Length (in)	24.0
No	Landing X Slope (%)	N/A	Yes	DWS Full Width?	Yes
N/A	Landing Curb? (Y/N)	No	Yes	DWS Offset (in)	0.0
N/A	Shared Landing?	No			
No	Gutter Ponding?	Yes	No	Gutter Slope (%)	8.2
No	Gutter Lip Ht (in)	0.5	Yes	Gutter X Slope (%)	0.8
N/A	Painted X Walk1?	Yes	N/A	Painted X Walk2?	N/A
	X Walk 1 Direction	To NW		X Walk 2 Direction	N/A
N/A	X Walk 1 Width (in)	92.0	N/A	X Walk 2 Width (in)	N/A
	X Walk 1 Slope (%)	2.9		X Walk 2 Slope (%)	N/A
	X Walk 1 X Slope (%)	0.5		X Walk 2 X Slope (%)	N/A

Yes	Ramp inside XWalk1?	Yes	N/A	Ramp inside XWalk2?	N/A
	Road Slope (%)	N/A	N/A	Clear Space?	Yes
	Road X Slope (%)	N/A	N/A	Clear Space to XWalk (in)	N/A
Yes	Any Obstructions?	No	Yes	Storm Grate/Utility Hazard?	No
	Obstruction Type			Storm Grate/Utility Type	
		N/A			N/A
			Yes	Surface Condition? (G/P)	Good

Possible Solutions:

**Install Landing. Remove & Replace Gutter.**

**R304.2.1, R304.2.2-Perp, R304.3.2-Para, R304.5.3, R302.7, R302.7.2, R304.5.4**
