## **Access Compliance Report Public Rights-of-Way** (Curb Ramps)

Intersection ID: 17196 Main Street: IDLEWILD\_RD **Cross Street: CONFERENCE\_DR** Location: NE **Overall Compliance: No** Severity Score: 21.25 **ADA ID: 1B81F8877FBB** Ramp Type: Perp Initial Pass/Fail: Fail

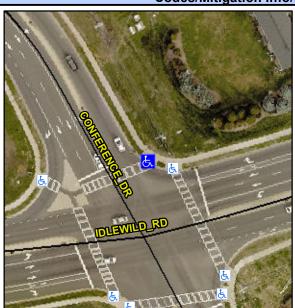
Field Measurements/Component Compliance								
Comp	liance Description	Data	Comp	liance	Description	Data		
N/A	Ramp Length (in)	66.0	No	Ramp	Slope (%)	11.1		
No	Ramp Width (in)	46.0	Yes	Yes Ramp XSlope (%)		1.9		
N/A	Flare Type LT	N/A	N/A	N/A Flare Type RT		N/A		
N/A	Flare Slope LT (%)	N/A	N/A	N/A Flare Slope RT (%)				
N/A	Flare Traversable LT?	N/A	N/A	Flare	Traversable RT?	N/A		
N/A	Landing Length (in)	N/A	N/A	DWS	Provided?	N/A		
N/A	Landing Width (in)	N/A	N/A	DWS Contrast?		N/A		
N/A	Landing Slope (%)	N/A	N/A	DWS	Length (in)	N/A		
N/A	Landing X Slope (%)	N/A	N/A	DWS	Full Width?	N/A		
N/A	Landing Curb? (Y/N)	N/A	N/A	DWS	Offset (in)	N/A		
N/A	Shared Landing?	N/A						
N/A	Gutter Ponding?	N/A	N/A	Gutte	r Slope (%)	N/A		
N/A	Gutter Lip Ht (in)	N/A	N/A	Gutte	r X Slope (%)	N/A		
N/A	Painted X Walk1?	Yes	N/A	Paint	ed X Walk2?	N/A		
	X Walk 1 Direction	To SW		X Wa	lk 2 Direction	N/A		
N/A	X Walk 1 Width (in)	114.0	N/A	X Wa	lk 2 Width (in)	N/A

X Walk 1 Slope (%)	1.6		X Wa	lk 2 Slope (%)	N/A		
	X Walk 1 X Slope (%)	2.9		X Wa	lk 2 X Slope (%)	N/A		
N/A	Ramp inside XWalk1?	Yes	N/A	Ramp	inside XWalk2?	N/A		
	Road Slope (%)	N/A	N/A	Clear	Space?	N/A		
	Road X Slope (%)	N/A	N/A	Clear	Space to XWalk (in)	N/A		
N/A	Any Obstructions?	N/A	N/A	Storm	n Grate/Utility Hazard?	N/A		
	Obstruction Type			Storm	n Grate/Utility Type			
		N/A				N/A		
			Yes	Surfa	ce Condition? (G/P)	Good

Possible Solutions:					
Remove & Replace Entire Ramp.					
·					
Surveyor Notes:					
N/A					
PROW/ADA:					
Not Found, R304.5.1, R304.2.2					
,

Total Cost:	\$ 1850.00
