# Access Compliance Report

## Public Rights-of-Way

### (Curb Ramps)

Intersection ID: N/A	Main Street: SHOPTON_RD	Cross Street: DIXIE_RIVER_RD	Location: SW
ADA ID: 1B836D9F27BB	Ramp Type: Para	Initial Pass/Fail: Fail	Overall Compliance: No
Severity Score: 26.25			
Codes/Mitigation Info/Possible Solution		Field Measurements/Component Compliance

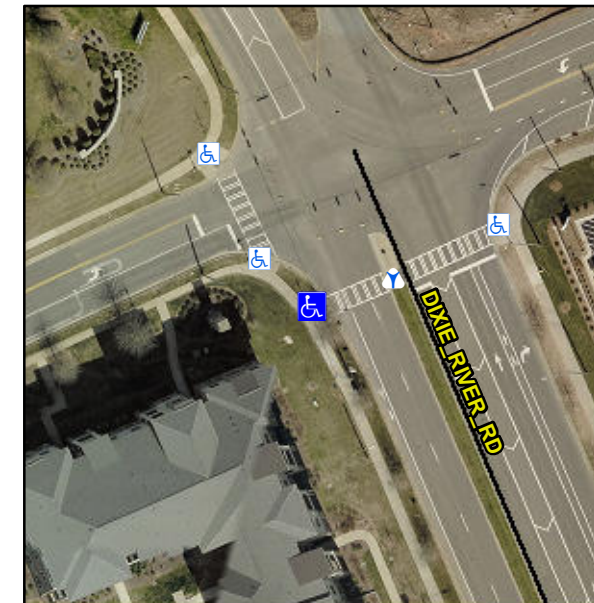
**RT RP < 5%**

**R304.3.2, R304.5.3**

Compliance	Description	Data	Compliance	Description	Data
N/A	Ramp Length LT (in)	66.0	N/A	Ramp Length RT (in)	64.0
Yes	Ramp Width LT (in)	95.0	Yes	Ramp Width RT (in)	96.0
No	Ramp Slope LT (%)	12.0	Yes	Ramp Slope RT (%)	2.9
No	Ramp XSlope LT (%)	2.3	No	Ramp XSlope RT (%)	3.8
N/A	Landing Length (in)	N/A	N/A	DWS Provided?	N/A
N/A	Landing Width (in)	N/A	N/A	DWS Contrast?	N/A
N/A	Landing Slope (%)	N/A	N/A	DWS Length (in)	N/A
N/A	Landing X Slope (%)	N/A	N/A	DWS Full Width?	N/A
N/A	Landing Curb? (Y/N)	N/A	N/A	DWS Offset (in)	N/A
N/A	Shared Landing?	N/A			
N/A	Gutter Ponding?	N/A	N/A	Gutter Slope (%)	N/A
N/A	Gutter Lip Ht (in)	N/A	N/A	Gutter X Slope (%)	N/A
N/A	Painted X Walk1?	Yes	N/A	Painted X Walk2?	N/A
	X Walk 1 Direction	To E		X Walk 2 Direction	N/A
N/A	X Walk 1 Width (in)	113.0	N/A	X Walk 2 Width (in)	N/A
	X Walk 1 Slope (%)	1.6		X Walk 2 Slope (%)	N/A
	X Walk 1 X Slope (%)	1.4		X Walk 2 X Slope (%)	N/A
N/A	Ramp inside XWalk1?	Yes	N/A	Ramp inside XWalk2?	N/A

Road Slope (%)	N/A	N/A	Clear Space?	N/A
	Road X Slope (%)	N/A	N/A	Clear Space to XWalk (in)	N/A
N/A	Any Obstructions?	N/A	N/A	Storm Grate/Utility Hazard?	N/A
	Obstruction Type			Storm Grate/Utility Type	
		N/A			N/A
			Yes	Surface Condition? (G/P)	Good
			N/A	Curb Slope (%)	6.8

**Remove & Replace Entire Ramp.**

Total Cost: \$ 1600.00
