## **Access Compliance Report Public Rights-of-Way** (Curb Ramps)

Intersection ID: 7619 Main Street: LOG CABIN RD Cross Street: SQUIRREL HILL RD SW Location: **Overall Compliance: No** Severity Score: 46.25 ADA ID: 1B8564C0C7D7 Ramp Type: Combination2 Initial Pass/Fail: Fail

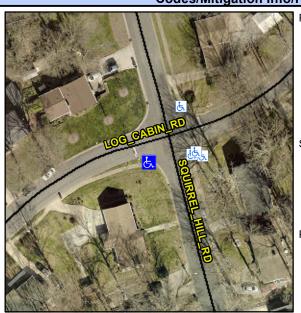
Street 1 Name None Stop Condition-Street 1 SQUIRREL HILL RD N/A Street 2 Name Stop Condition-Street 2 N/A Possible Solutions: Remove & Replace Entire Ramp. Surveyor Notes: **GTR GAP 6.0, LT RP < 5%** PROW/ADA: Not Found, R304.5.1, R304.2.2, R304.5.3, R304.3.2
