# Access Compliance Report

## Public Rights-of-Way

### (Curb Ramps)

| Intersection ID: 10041465 | Main Street: WESTMINSITER_PL | Cross Street: N/A | Location: NW |

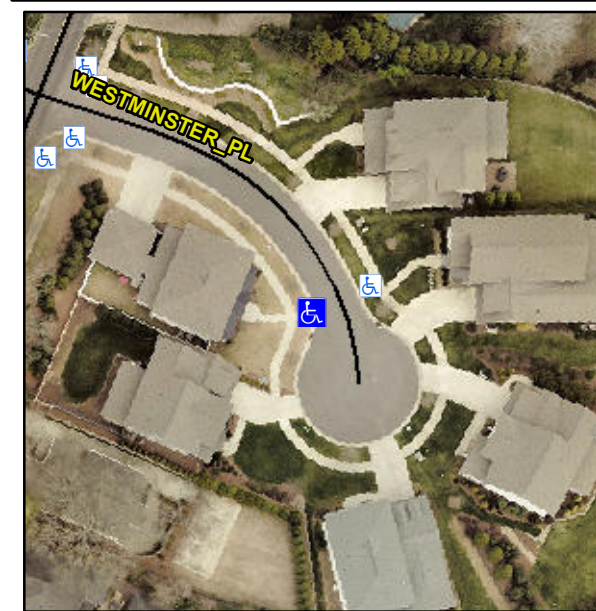
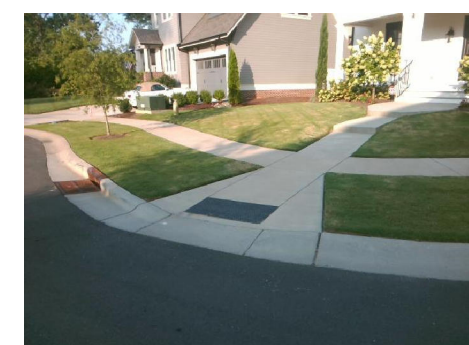
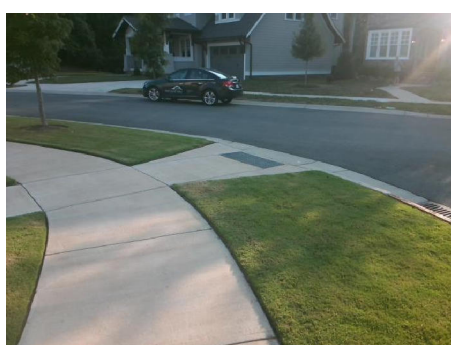
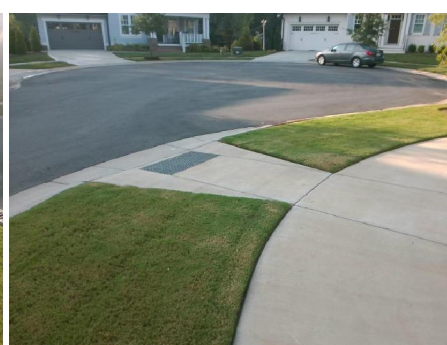
| ADA ID: 1B8B58DBB498 | Ramp Type: Perp | Initial Pass/Fail: Fail | Overall Compliance: No |

**R304.5.1, R304.5.3**

| Compliance | Description | Data | Compliance | Description | Data |
|---|---|---|---|---|---|
| No | Ramp Width (in) | 46.0 | No | Ramp XSlope (%) | 3.2 |

**Remove & Replace Entire Ramp.**

Total Cost: \$ 1850.00
