Access Compliance Report

Public Rights-of-Way

(Curb Ramps)

Intersection ID: 5784	Main Street: FOSTER_BROOK_DR	Cross Street: OAKDALE_GREEN_DR	Location: NW
ADA ID: 1B908B66BEB8	Ramp Type: BlendTrans2	Initial Pass/Fail: Fail	Overall Compliance: No
Severity Score: 17.5			
Codes/Mitigation Info/Possible Solution		Field Measurements/Component Compliance

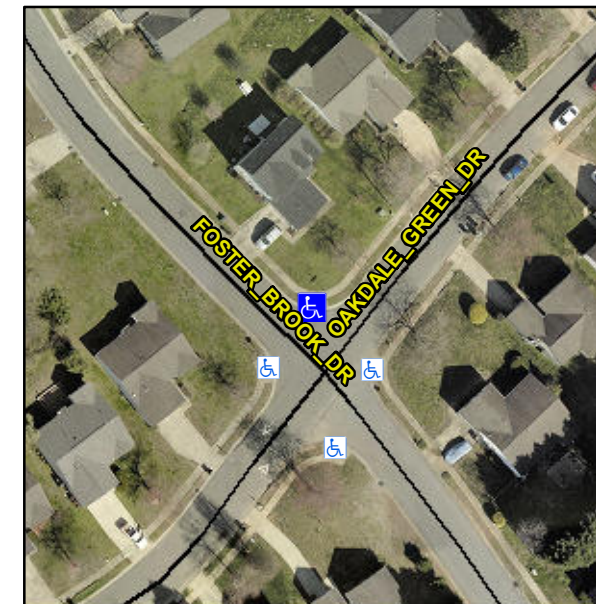
Not Found, R304.5.1

Compliance	Description	Data	Compliance	Description	Data
N/A	Ramp Length (in)	98.0	Yes	BlendTrans Slope (%)	3.2
No	Ramp Width (in)	32.0	Yes	BlendTrans XSlope (%)	1.9
N/A	Flare Type LT	N/A	N/A	Flare Type RT	N/A
N/A	Flare Slope LT (%)	N/A	N/A	Flare Slope RT (%)	N/A
N/A	Flare Traversable LT?	N/A	N/A	Flare Traversable RT?	N/A
N/A	Landing Length (in)	N/A	N/A	DWS Provided?	N/A
N/A	Landing Width (in)	N/A	N/A	DWS Contrast?	N/A
N/A	Landing Slope (%)	N/A	N/A	DWS Length (in)	N/A
N/A	Landing X Slope (%)	N/A	N/A	DWS Full Width?	N/A
N/A	Landing Curb? (Y/N)	N/A	N/A	DWS Offset (in)	N/A
N/A	Shared Landing?	N/A			
N/A	Gutter Ponding?	N/A	N/A	Gutter Slope (%)	N/A
N/A	Gutter Lip Ht (in)	1.0	N/A	Gutter X Slope (%)	N/A
N/A	Painted X Walk1?	No	N/A	Painted X Walk2?	No
	X Walk 1 Direction	To SW		X Walk 2 Direction	To SE
	X Walk 1 Width (in)	N/A		X Walk 2 Width (in)	N/A
	X Walk 1 Slope (%)	0.6		X Walk 2 Slope (%)	4.1
	X Walk 1 X Slope (%)	3.9		X Walk 2 X Slope (%)	0.5

N/A	Ramp inside XWalk1?	N/A	N/A	Ramp inside XWalk2?	N/A
	Road Slope (%)	2.2		Clear Space?	N/A
	Road X Slope (%)	4.0	N/A	Clear Space to XWalk (in)	N/A
N/A	Any Obstructions?	N/A	N/A	Storm Grate/Utility Hazard?	N/A
	Obstruction Type			Storm Grate/Utility Type	
		N/A			N/A
			Yes	Surface Condition? (G/P)	Good
			No	Curb Slope (%)	14.7

Possible Solutions:

Remove & Replace Curb Ramp With Two New Directional Ramps or Equivalent.
