# Access Compliance Report

## Public Rights-of-Way

### (Curb Ramps)

Intersection ID: 10025384	Main Street: E_9TH_ST	Cross Street: N/A	Location: N
ADA ID: 1B91D89A4E7E	Ramp Type: Perp	Initial Pass/Fail: Fail	Overall Compliance: No
Severity Score: 8.75			
Codes/Mitigation Info/Possible Solution		Field Measurements/Component Compliance

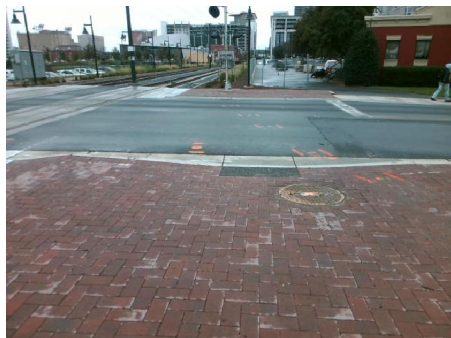
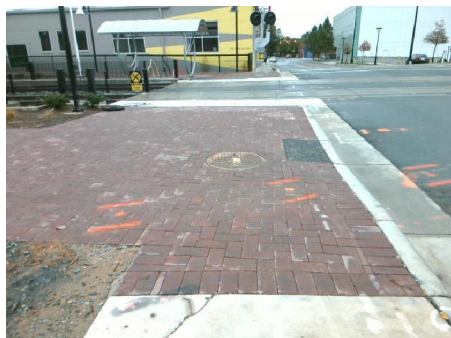
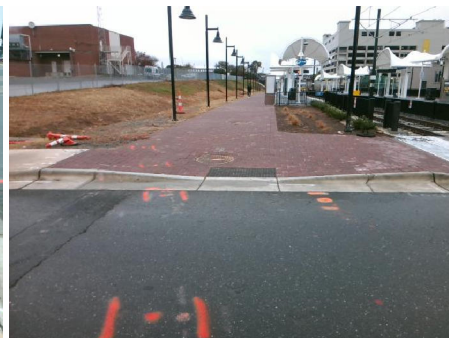
**Not Found, R304.5.1**

Compliance	Description	Data	Compliance	Description	Data
N/A	Ramp Length (in)	71.0	Yes	Ramp Slope (%)	5.2
No	Ramp Width (in)	47.5	Yes	Ramp XSlope (%)	0.2
N/A	Flare Type LT	N/A	N/A	Flare Type RT	N/A
N/A	Flare Slope LT (%)	N/A	N/A	Flare Slope RT (%)	N/A
N/A	Flare Traversable LT?	N/A	N/A	Flare Traversable RT?	N/A
N/A	Landing Length (in)	N/A	N/A	DWS Provided?	N/A
N/A	Landing Width (in)	N/A	N/A	DWS Contrast?	N/A
N/A	Landing Slope (%)	N/A	N/A	DWS Length (in)	N/A
N/A	Landing X Slope (%)	N/A	N/A	DWS Full Width?	N/A
N/A	Landing Curb? (Y/N)	N/A	N/A	DWS Offset (in)	N/A
N/A	Shared Landing?	N/A			
N/A	Gutter Ponding?	N/A	N/A	Gutter Slope (%)	N/A
N/A	Gutter Lip Ht (in)	N/A	N/A	Gutter X Slope (%)	N/A
N/A	Painted X Walk1?	No	N/A	Painted X Walk2?	N/A
	X Walk 1 Direction	To SW		X Walk 2 Direction	N/A
N/A	X Walk 1 Width (in)	N/A	N/A	X Walk 2 Width (in)	N/A
	X Walk 1 Slope (%)	2.9		X Walk 2 Slope (%)	N/A
	X Walk 1 X Slope (%)	1.5		X Walk 2 X Slope (%)	N/A

N/A	Ramp inside XWalk1?	N/A	N/A	Ramp inside XWalk2?	N/A
	Road Slope (%)	N/A	N/A	Clear Space?	N/A
	Road X Slope (%)	N/A	N/A	Clear Space to XWalk (in)	N/A
N/A	Any Obstructions?	N/A	N/A	Storm Grate/Utility Hazard?	N/A
	Obstruction Type			Storm Grate/Utility Type	
		N/A			N/A
		Yes		Surface Condition? (G/P)	Good

**Remove & Replace Entire Ramp.**
