Access Compliance Report

Public Rights-of-Way

(Curb Ramps)

Intersection ID: 46693	Main Street: GOLDFIELDS_DR	Cross Street: OLD_MEADOW_RD	Location: NE
ADA ID: 1B9A12E0CBBB	Ramp Type: PerpDiag	Initial Pass/Fail: Fail	Overall Compliance: No
			Severity Score: 13.75

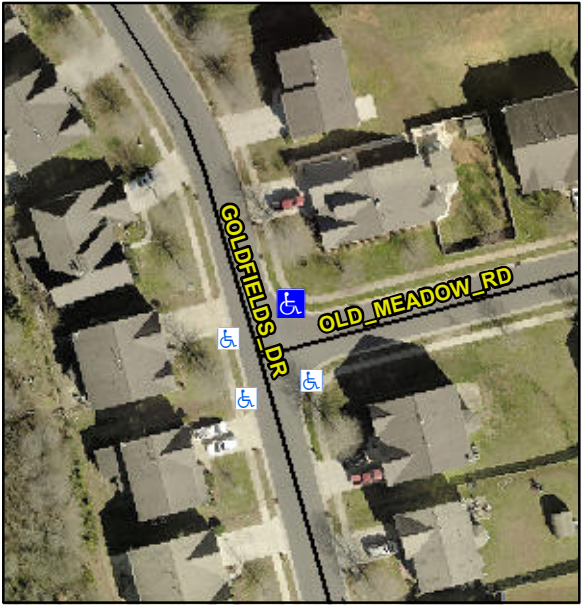
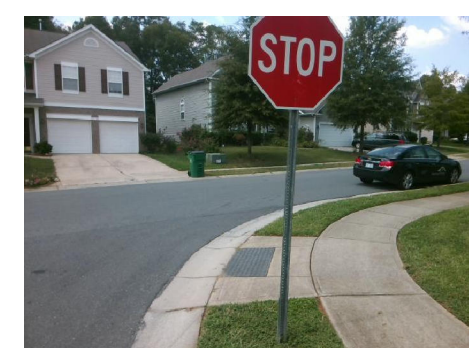
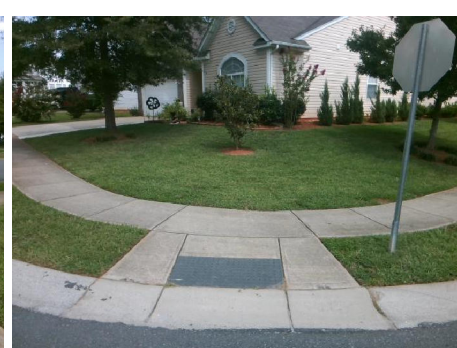
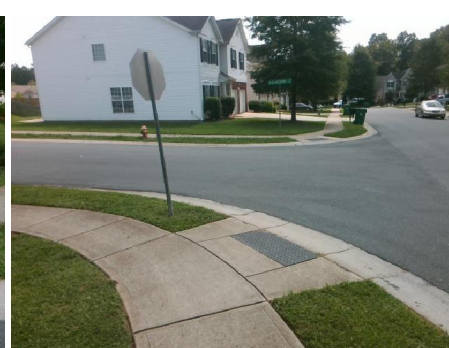
Possible Solutions:						
	Remove & Replace Curb Ramp With Two New Directional Ramps or Equivalent.						
	Surveyor Notes:						
	N/A						
	PROW/ADA:						
	Not Found, R304.2.2, R304.5.3						
		Compliance	Description	Data	Compliance	Description	Data
		N/A	Ramp Length (in)	46.5	No	Ramp Slope (%)	9.1
		Yes	Ramp Width (in)	48.0	No	Ramp XSlope (%)	2.4
		N/A	Flare Type LT	N/A	N/A	Flare Type RT	N/A
		N/A	Flare Slope LT (%)	N/A	N/A	Flare Slope RT (%)	N/A
		N/A	Flare Traversable LT?	N/A	N/A	Flare Traversable RT?	N/A
		N/A	Landing Length (in)	N/A	N/A	DWS Provided?	N/A
		N/A	Landing Width (in)	N/A	N/A	DWS Contrast?	N/A
		N/A	Landing Slope (%)	N/A	N/A	DWS Length (in)	N/A
		N/A	Landing X Slope (%)	N/A	N/A	DWS Full Width?	N/A
		N/A	Landing Curb? (Y/N)	N/A	N/A	DWS Offset (in)	N/A
		N/A	Shared Landing?	N/A			
		N/A	Gutter Ponding?	N/A	N/A	Gutter Slope (%)	N/A

N/A	Gutter Lip Ht (in)	N/A	N/A	Gutter X Slope (%)	N/A
		N/A	Painted X Walk1?	No	N/A	Painted X Walk2?	No
			X Walk 1 Direction	To W		X Walk 2 Direction	To S
		N/A	X Walk 1 Width (in)	N/A	N/A	X Walk 2 Width (in)	N/A
			X Walk 1 Slope (%)	2.4		X Walk 2 Slope (%)	1.5
			X Walk 1 X Slope (%)	1.1		X Walk 2 X Slope (%)	2.5
		N/A	Ramp inside XWalk1?	N/A	N/A	Ramp inside XWalk2?	N/A
			Road Slope (%)	2.4	N/A	Clear Space?	N/A
			Road X Slope (%)	3.3	N/A	Clear Space to XWalk (in)	N/A
		N/A	Any Obstructions?	N/A	N/A	Storm Grate/Utility Hazard?	N/A
			Obstruction Type			Storm Grate/Utility Type	
				N/A			N/A
					Yes	Surface Condition? (G/P)	Good
Total Cost:		\$	3200.00
